Beechcraft SERVICE BULLETIN

MODEL: 23

No. 1

SUBJECT: ADDITION OF GENERATOR TERMINAL NIPPLES AND DEFLECTOR REWORK

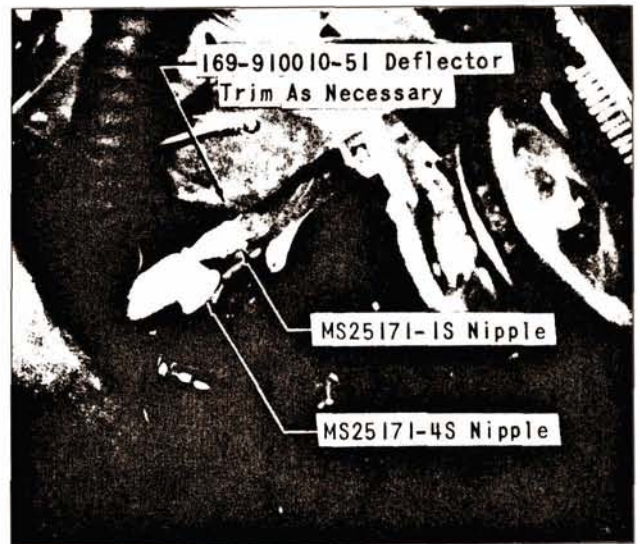
DESCRIPTION: The 169-910010-51 deflector located directly above the generator post on the Model 23 Musketeer, may under varying air loads, occasionally touch the terminal post on the generator and cause electrical surges through the electrical system and its components. This condition has been corrected by factory modification on Musketeers, Serial M-105 and after, and should be corrected on prior aircraft as follows:

1. Make sure the master switch is turned OFF.
2. Disconnect the leads to the generator and install an MS25171-1S and an MS25171-4S terminal nipple on the generator posts as shown in the illustration.
3. Trim the corner of the 169-910010-51 deflector as necessary so that the deflector will clear the generator post if varying air loads force the deflector down.
