No. 2003
ATA Code 32-10
Recurring Inspection

SUBJECT: LANDING GEAR - INSPECTION AND/OR MODIFICATION OF COMPONENTS ON THE MAIN LANDING GEAR STRUT ASSEMBLIES

EFFECTIVITY: BEECHCRAFT Skipper 77, serials WA-1 through WA-312.

Service Bulletin No. 2003

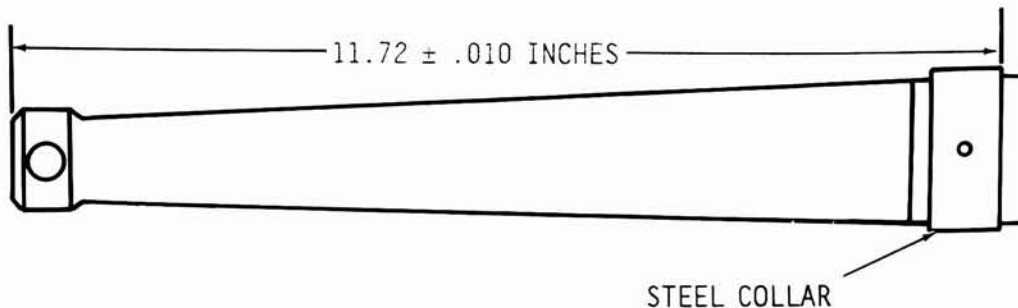
Figure 1.

2. Inspect the main landing gear strut for security of the steel collar to the strut (see Figure 1). If the distance between the steel collar and the end of the strut is greater than $11.72 \pm .010$ inches as shown in Figure 1, the collar has separated. If the collar has separated, remove the collar and thoroughly clean the strut at the collar location. Remove all traces of bonding agent with 200 grit sandpaper (obtain locally). If the collar is secure, proceed to step 7.

3. Clean the steel collar completely, removing all traces of bonding material from the inner recessed area of the collar using 200 grit sandpaper. Use care not to remove any metal from the edge of the collar.

6. With the strut supported on a bench, locate the collar on the strut in accordance with Figure 1 using care not to contaminate prepared surfaces. Inject P/N EA9309 QT adhesive (mix per manufacturers instructions) into the hole in the collar using a disposable 3 c.c. syringe (obtain locally). Carefully rotate the collar, maintaining the correct collar location, and inject adhesive into the collar a second time. **REPEAT THE PROCEDURE UNTIL CERTAIN THAT NO AIR POCKETS REMAIN INSIDE THE COLLAR.** Re-check the measurements in accordance with Figure 1, and tape the collar in place with masking tape. Allow adhesive to cure 24 hours at room temperature before installing the strut. The use of a heat lamp approximately 12-15 inches from strut is recommended. After curing, remove all excess adhesive from the strut and collar using scotch-brite or equivalent (obtain locally).

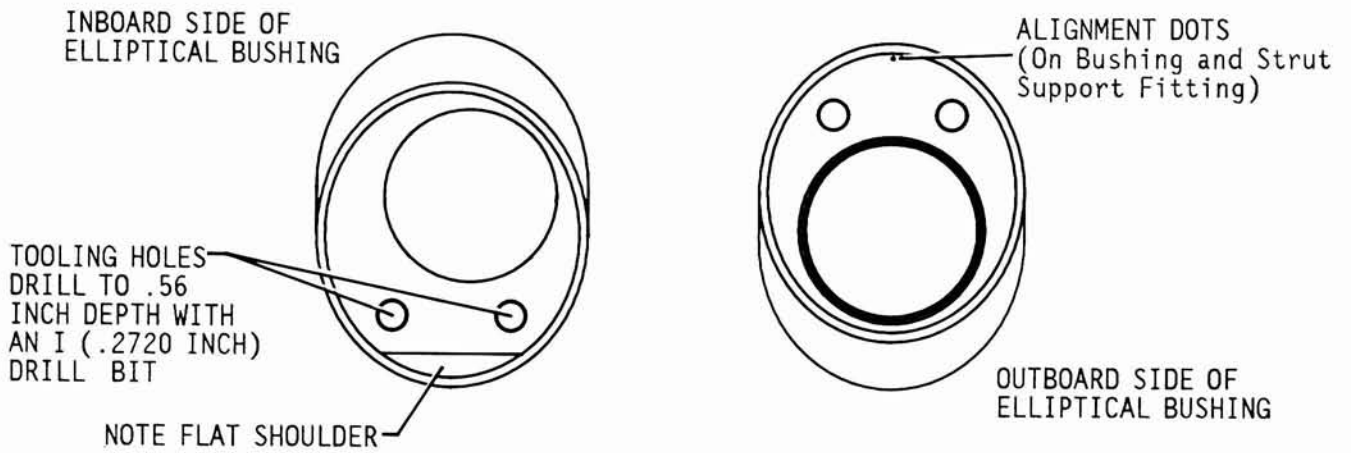
Figure 2.

Inspect the condition of the Urethane coating on the elliptical bushing. If the coating is damaged, a new bushing will be required.

7. Locate the two tooling holes in the inboard side of the elliptical bushing. Drill the holes to a depth of .56 inch with an I (.2720 inch) drill bit. Tap the holes to 5/16-24 thread starting with a tapered tap and finishing with a bottoming tap (refer to Figure 2).

9. Reinstall the landing gear strut after the bonding adhesive (if required in Step 4) has cured. Make certain the alignment dots on the elliptical bushing and strut support fitting (see Figure 2) are aligned exactly. Torque the brace nut (see Figure 3) to 125-150 inch pounds with a spanner wrench while holding the bushing in place. The alignment dots **MUST** align after the brace nut is torqued. Safety wire the brace nut, using P/N MS20995C32 safety wire (obtain locally).

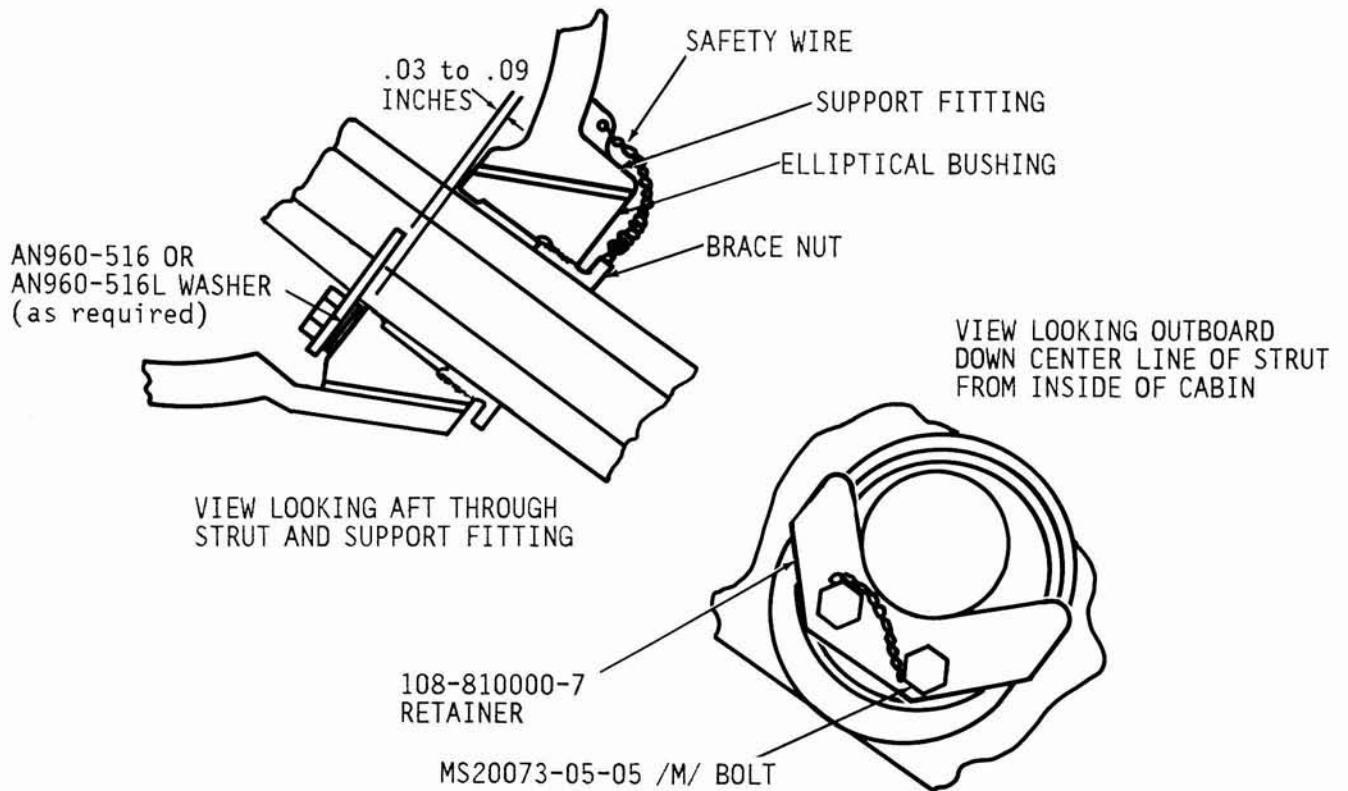
Figure 3.

13. The recurring inspection should be repeated each 100 service hours thereafter to assure .03 to .09 inch clearance between the retainer and support fitting.

10. Install a P/N 108-810000-7 retainer as shown in Figure 3, using two P/N MS20073-05-05 /M/ bolts. Place P/N AN960-516 or P/N AN960-516L washers between the bushing and retainer as required to maintain a spacing of .03 to .09 inch between the retainer and support fitting (refer to Figure 3). Torque the bolts to 56-78 inch-pounds and safety wire.
