No. 2006  
ATA Code 24-50

**SUBJECT: ELECTRICAL POWER - INSTRUMENT PANEL GROUND STRAP INSTALLATION**

## Service Bulletin No. 2006

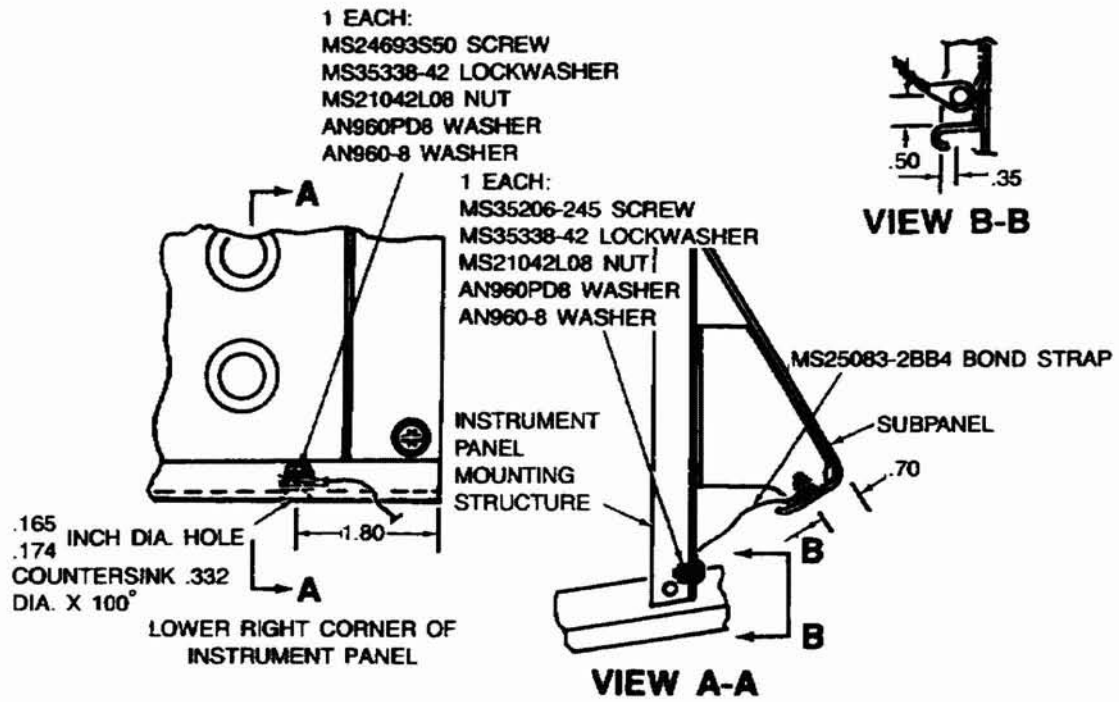
**REASON:** To provide an improved ground between the instrument panel and the aircraft.

4. On the lower right hand corner of the instrument subpanel, drill a .165 to .175 inch diameter hole in the bottom lip. Countersink the hole to .332 inch diameter with a 100 degree countersink. (see Figure 1)

6. On the lower right hand instrument panel mounting structure, drill a .165 to .174 inch diameter hole just above the "J" stringer as depicted in Figure 1, views A-A and B-B. Clean the area per step 5.

9. Insulate the bond strap with P/N 106242C2 heat shrink tubing or equivalent and a heat gun. Install the free end of the bond strap at the newly drilled location on the instrument panel mounting structure using a P/N MS35206-245 screw, a P/N AN960PD8 washer under the terminal lug, a P/N AN960-8 washer, a P/N MS35338-42 lockwasher and a P/N MS21042L08 nut. (see Figure 1 view A-A)
