No. 2009
ATA Code 32-30

SUBJECT: LANDING GEAR - INSPECTION OF NOSE LANDING GEAR ATTACH BOLTS AND INSTALLATION OF BUSHINGS

EFFECTIVITY: BEECHCRAFT Duchess 76, serials ME-1 through ME-437.

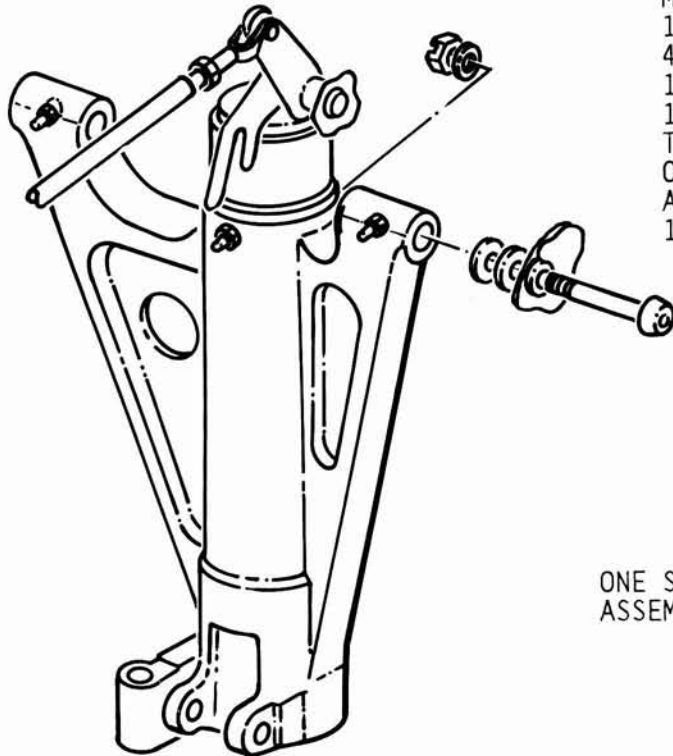
REASON: To reduce the possibility of the nose landing gear attach bolt holes becoming elongated.

ONE SIDE SHOWN. BOTH SIDES ASSEMBLED IN THE SAME MANNER

- MS20006-35 /M/ BOLT
- 105-410000-295 BUSHING (UNDER HEAD)
- 45-825011 BUSHING
- 100951S032YP WASHER
- 100951S016YP WASHER (AS REQUIRED TO OBTAIN A TOTAL END CLEARANCE OF .001 to .017 INCH)
- AN960-616 WASHER (UNDER NUT)
- 130909N25 NUT

8. Refer to the illustration and install the P/N 100951S032YP or P/N 100951S016YP washers to obtain a total end clearance of .001 to .017 inch.

9. Install the P/N MS20006-35 /M/ bolts with the bolt heads outboard of the keels.

10. Install the P/N AN960-616 washers, torque the P/N 130909N25 nuts to 72 to 108 inch-pounds.
