**Kit No. 76-4004-1 S**

**SUBJECT:** **WINGS - INSTALLATION OF WASHERS ON THE WING LOWER SPLICE PLATE BOLTS AND INSPECTION OF THE WING UPPER SPLICE PLATE**

**EFFECTIVITY:** BEECHCRAFT Duchess 76, serials ME-3 through ME-377, ME-379 through ME-428, ME-430 and ME-432.

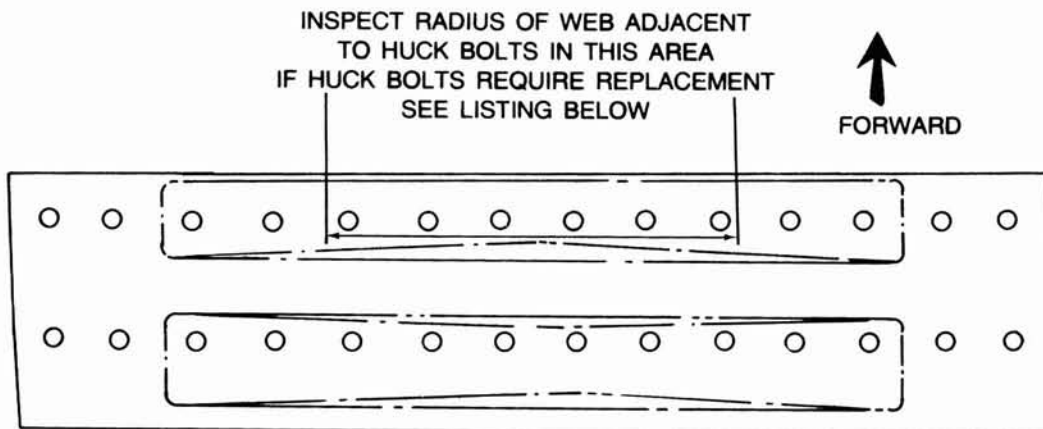
### UPPER SPLICE PLATE Figure 2

5. Inspect the wing upper splice adjacent to each of the six center forward Huck bolts for tool marks in the radius of the web and splice plate. See Figure 2.

6. If no tool marks are found, proceed to Step 14.
7. If tool marks are found, and are less than .050 inch deep, remove the affected Huck bolts in the upper splice plate by splitting the collars with a P/N 105-10 collar splitter or equivalent and pushing the Huck bolts out.

8. Polish the tool marks out evenly using aluminum oxide paper or cloth. Finish polish with 400 grit or finer aluminum oxide paper or cloth.
9. If the tool marks are deeper than .050 inch, contact:  
Beech Aircraft Corporation Commercial Service Department Wichita, Kansas Telephone (316) 681-8495 TWX No. 203603
10. Coat the areas which were polished in Step 8 with ALODINE 1200, 1200S or 1201 chemical conversion coating (obtain locally). Allow the coating to dwell (five minutes). Wash the coated areas with water and blow dry with air (do not wipe dry). Paint the treated areas with zinc chromate primer (obtain locally) and allow to dry.

130909B98 BOLTS  
MS20002C5 WASHERS (UNDER BOLT HEAD)  
AN960-516 WASHERS (UNDER NUT-MAX. 3 EA. BOLT)  
MS20365-524A NUTS

TORQUE ON NUTS 100-125 INCH POUNDS  
TORQUE ON BOLT 130-135 INCH POUNDS

11. Install a P/N 130909B98 bolt (head up), with a P/N MS20002C5 washer under each bolt head into the the upper splice plate. Ensure that the chamfered side of the washer is against the bolt head.
12. Install a P/N AN960-516 washer and a P/N MS20365-524A nut on the bolts which were installed in the previous step. A maximum of three P/N AN960-516 washers may be used under each nut.
13. Torque the nuts to 100-125 inch pounds or the bolt heads to 130-140 inch pounds.
14. Reinstall the spar cover, spar inspection plate and the floorboard assemblies.
