No. 2050
ATA Code 32-10

SUBJECT: LANDING GEAR - INSTALLATION OF AN IMPROVED FLATHEAD PIN ON THE MAIN LANDING GEAR FORK PIN

EFFECTIVITY: BEECHCRAFT A24R, B24R and C24R Sierra 200, serials MC-2 through MC-683.

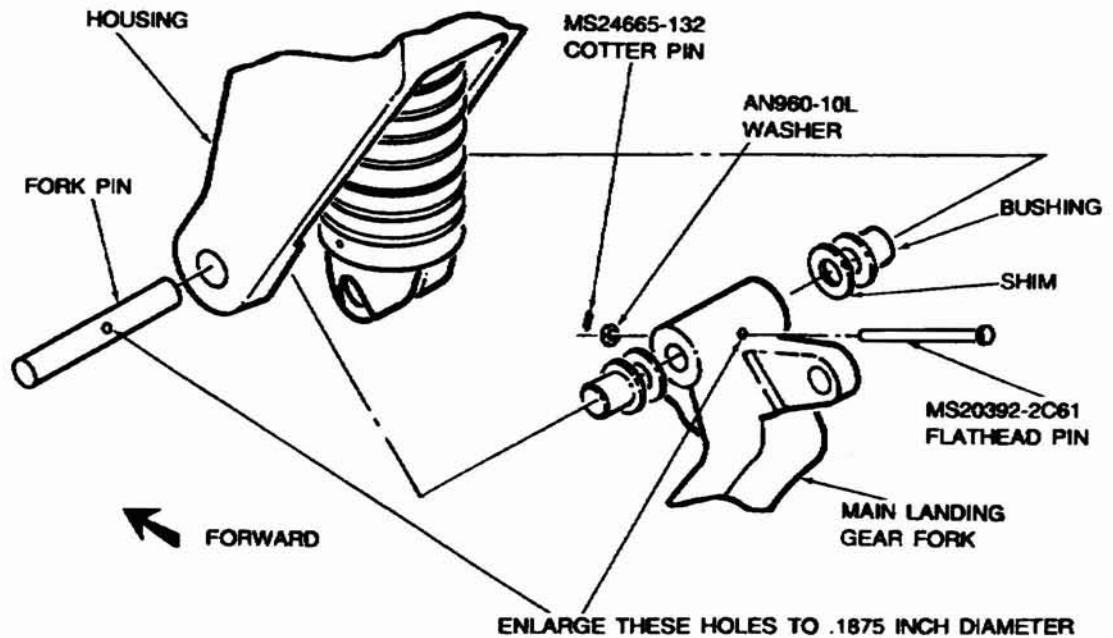
REASON: To improve retention of the main landing gear fork pin by installing a larger diameter flathead pin.

8. Reinstall the main landing gear fork pin in the landing gear fork and housing. Refer to the illustration and install the new P/N MS20392-2C61 flathead pin, P/N AN960-10L washer, P/N MS24665-132 cotter pin.
