No. 2148
ATA Code 74-30

SUBJECT: IGNITION - REMOVAL OF GROUNDING TAB FROM IGNITION SWITCH

EFFECTIVITY: BEECHCRAFT 76 Duchess, serials ME-3 through ME-437.

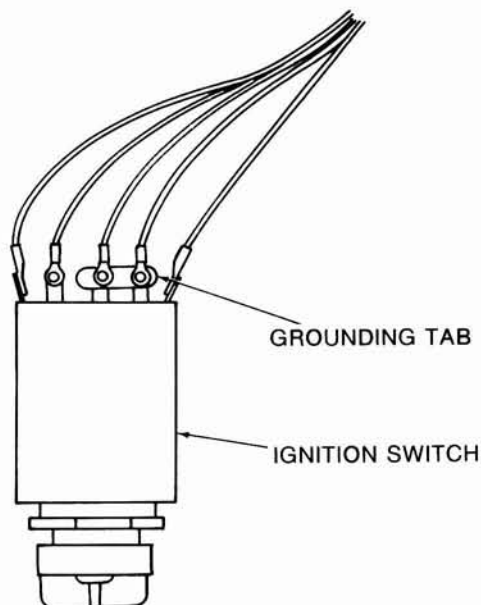
Figure 1

connects to terminal "R" and wire J2A22 connects to terminal "L".

Tag the two wires which are connected by a grounding tab (see illustration). On the RH magneto, wire J4A22 connects to terminal "R" and wire J5A22 connects to terminal "L". On the LH magneto, wire J1A22

2. Refer to the illustration, remove the grounding tab and reattach the wires to the appropriate terminals.
3. Reinstall the ignition switch using the attaching hardware which was removed in Step 1.
4. Repeat this procedure on the opposite ignition switch.
