No. 2176
ATA Code 27-50, 32-30

SUBJECT: FLIGHT CONTROLS - MODIFICATION OF FLAP AND LANDING GEAR SELECTOR SWITCH KNOBS

Service Bulletin No. 2176

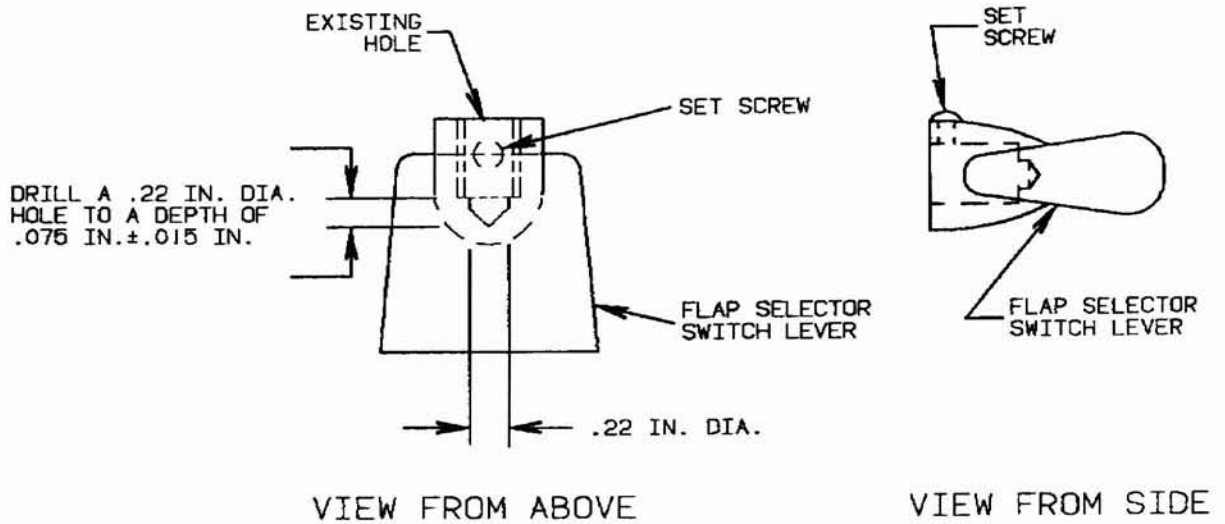
**Flap Selector Switch Lever Modification
Figure 1**

REASON: This Service Bulletin is being issued to modify flap and landing gear selector switch knobs so that they cannot disengage the switch lever lock feature. If the knobs are overtightened, there is a possibility that the switches could be activated unintentionally.

1. Remove the flap selector lever by loosening the set screw and unscrewing the lever from the selector switch.
2. Drill a .22 inch diameter hole down through the center of the existing mounting hole to a depth of .075 inch \pm .015 inch, as shown in Figure 1.
3. Reinstall the lever on the switch.
4. Tighten the set screw.
