No. 2198, Rev. I
ATA Code 27-10

Kit No. 23-4013-1 S

SUBJECT: FLIGHT CONTROLS - INSPECTION AND/OR REPLACEMENT OF AILERON PUSH ROD FORWARD ROD END

Service Bulletin No. 2198, Rev. I

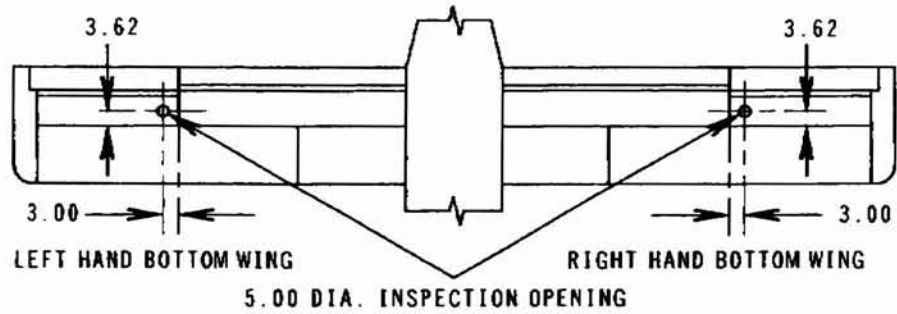
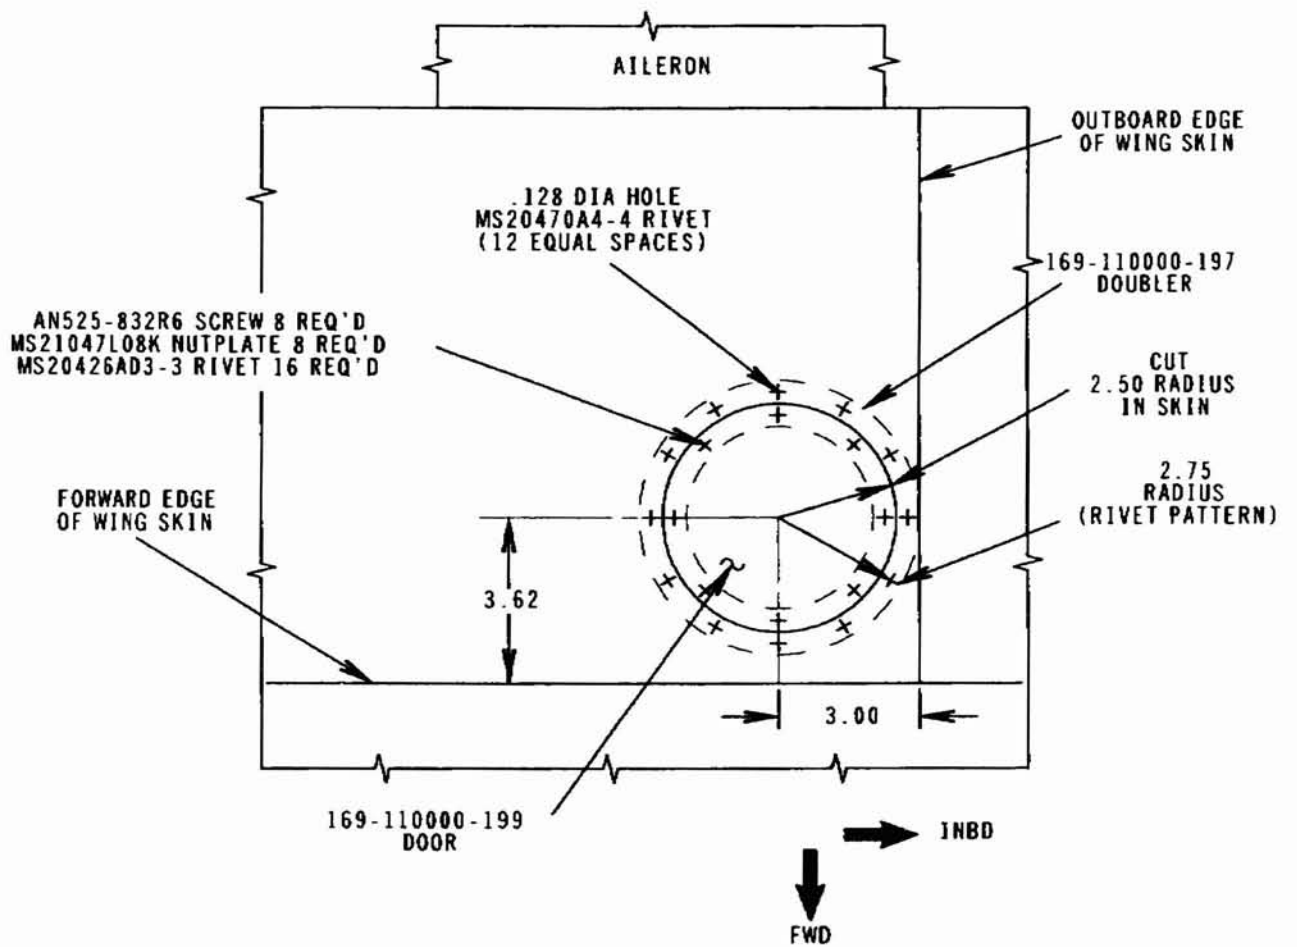
VIEW LOOKING FROM BELOW AT LH WING
Figure 1

1. If it is not possible to include the existing hole in the new hole, locate the center point of the new inspection hole 4.75 inches outboard from the outboard edge of the wing skin, instead of the 3.0 inches shown in Figure 1. (All other dimensions shown in Figure 1 will still be applicable.)

2. Locate a point on the underside of the L.H. wing 3.62 inches from the forward edge of the wing skin and 3.0 inches from the outboard edge of the wing skin as shown in Figure 1. Using this as a center point, lay out a hole 5 inches in diameter.

3. Cut the inspection hole in the skin which was laid out in Step 2.
