**SUBJECT:** ELECTRICAL POWER - REMOVAL OF REVERSE CURRENT DIODE FROM ALTERNATOR SYSTEM

BEECHCRAFT Skipper 77, serials WA-1 through WA-312.

**Issued: June, 1987**

**Revised: December, 1987**

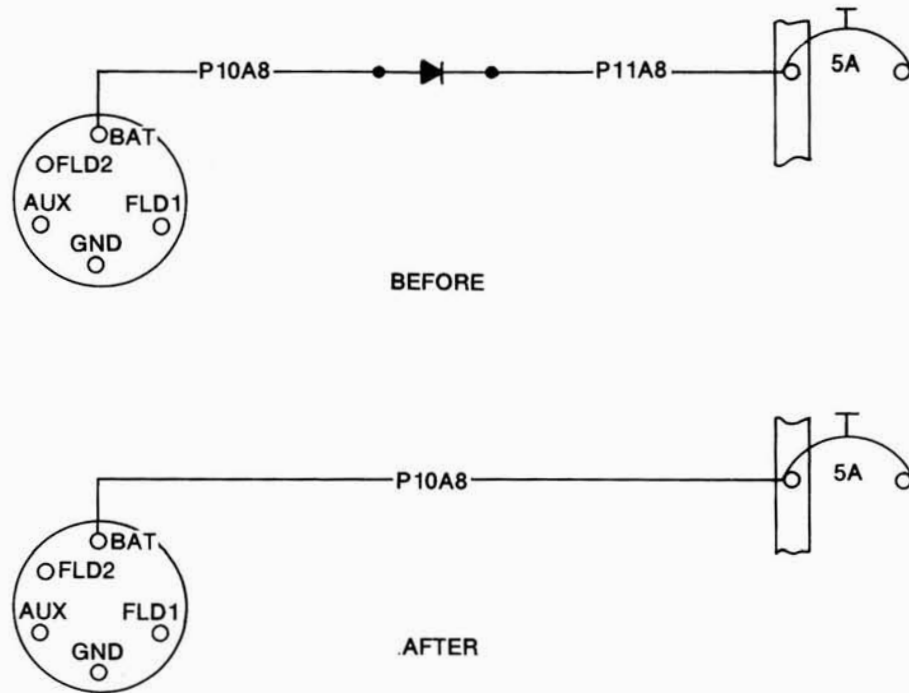
Figure 1

Beech Aircraft Corporation is issuing this Service Bulletin to reduce the possibility of the subject diode overheating and causing smoke in the cockpit. Subsequent review reveals the diode to be unnecessary, therefore, it should be removed from the electrical circuit on all affected airplanes.

1. Turn off and disconnect all electrical power and disconnect the battery.
2. Gain access to the alternator reverse current diode which is located on the forward side of the Power Control Quadrant Panel.
3. Remove and discard the reverse current diode.
4. Cut a piece of 8 gage wire which conforms to MIL-W-22759/16 or MIL-W-5086, approximately 70 inches long.
5. Attach terminals to the ends of the wire as follows:
  - a. Attach either a P/N 330968 or P/N 332042 terminal (P/N's of AMP Inc., Harrisburg, PA) to the alternator terminal of the wire.
  - b. Attach a P/N 322047 terminal to the bus bar end of the wire.
6. Permanently mark the wire "P10A8" within three inches of both ends.
7. Refer to the illustration and replace existing wires P10A8 and P11A8 with the wire fabricated in Steps 4 through 6.
8. Restore electrical power to the airplane.
