No. 2241, Rev. I
ATA Code 32-20
Recurring Inspection

SUBJECT: LANDING GEAR - INSPECTION/REPLACEMENT OF NOSE LANDING GEAR FORK

Service Bulletin No. 2241, Rev. I

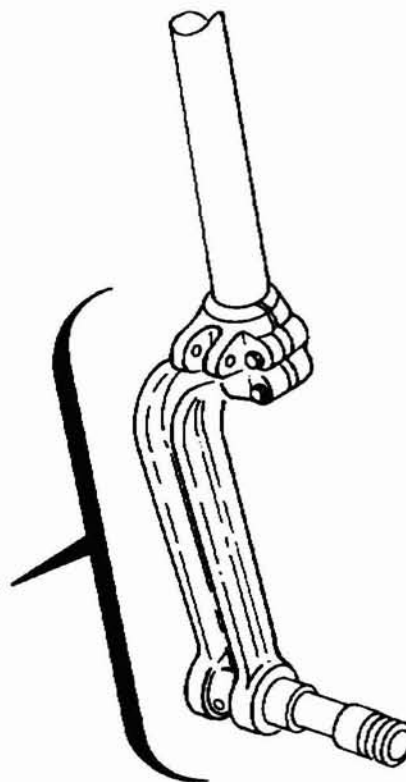
EXISTING FORK INSPECTION
Figure 1

This Service Bulletin is being issued to inspect for possible cracks in the nose landing gear fork. The nose fork, wheel and tire could separate from the aircraft if a crack progresses sufficiently.

1. Visually inspect the nose landing gear fork for cracks. Pay special attention to the forward and aft upper surfaces of the lower "I" section flange, at the transition radius where the flange blends into the piston socket boss. See Figure 1.
2. Perform a fluorescent penetrant inspection as follows:

EXISTING INSTALLATION
INSPECT ENTIRE SURFACE AREA OF
EXISTING LANDING GEAR FORK

5. If cracks are discovered in the nose landing gear fork and axle assembly, replace the fork with a new P/N 108-820010-653 landing gear fork in accordance with the Maintenance Manual.

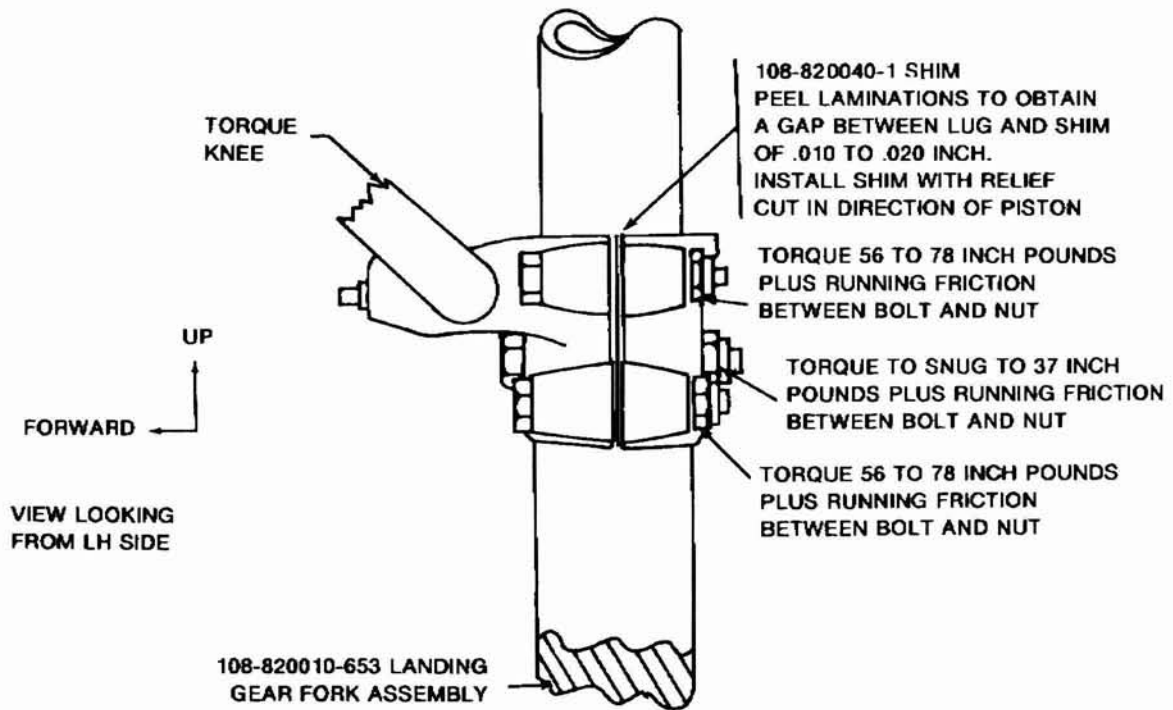
LAMINATED SHIM INSTALLATION
Figure 2

Corrected gap measurement and illustration orientation of Figure 2; added SPARES AFFECTED statement.

Use Figure 2 in conjunction with the existing Maintenance Manual procedures.
