77

No. 2243  
ATA Code 32-10

**SUBJECT:** LANDING GEAR - INSTALLATION OF MAIN LANDING GEAR SINGLE PIECE BRACE NUT AND COLLAR AND ELLIPTICAL BUSHING RETAINER

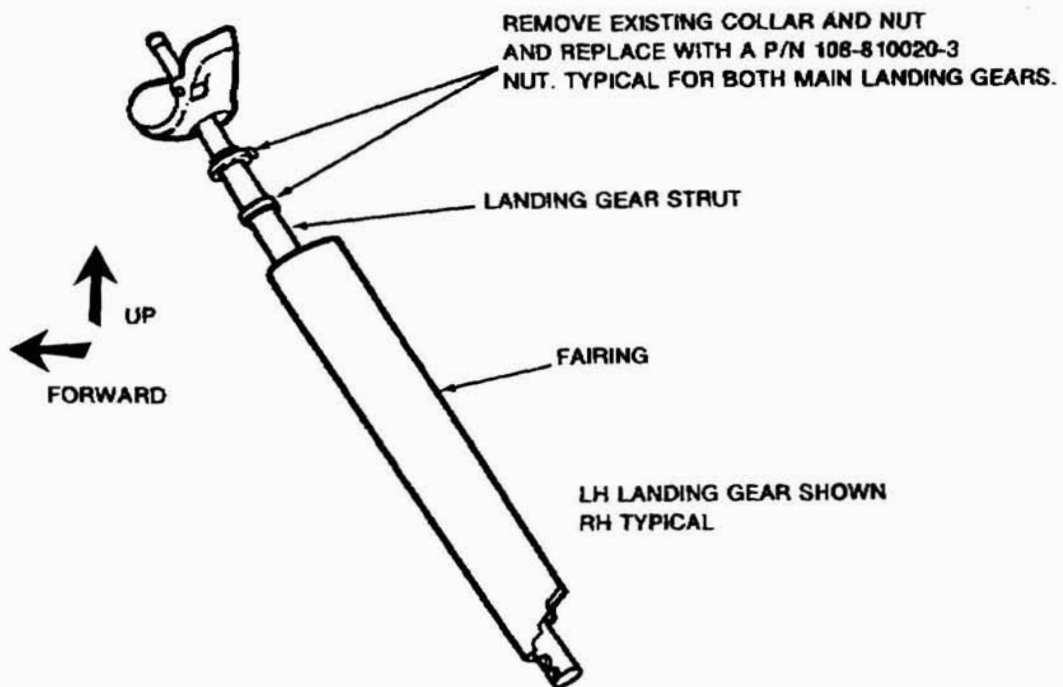
**REASON:** This Service Bulletin is being issued to offer a single piece retainer nut and improved elliptical bushing retainer for the main landing gear strut in the fuselage support fitting. Beech Aircraft Corporation has received reports of debonding of the strut collars resulting in landing gear looseness and vibration during ground operations.

1. Refer to Chapter 7 of the Maintenance Manual and place the airplane on jacks.
2. Refer to Chapter 32-10 of the Maintenance Manual for removal of the main landing gear. Remove only one gear at a time.
3. Refer to Figure 1 and remove and discard the existing collar and nut from the LH, RH or both landing gear struts. Remove the adhesive from the strut.

The use of moderate heat (do not exceed 200°) may be advantageous in the removal of the existing collars and nuts.

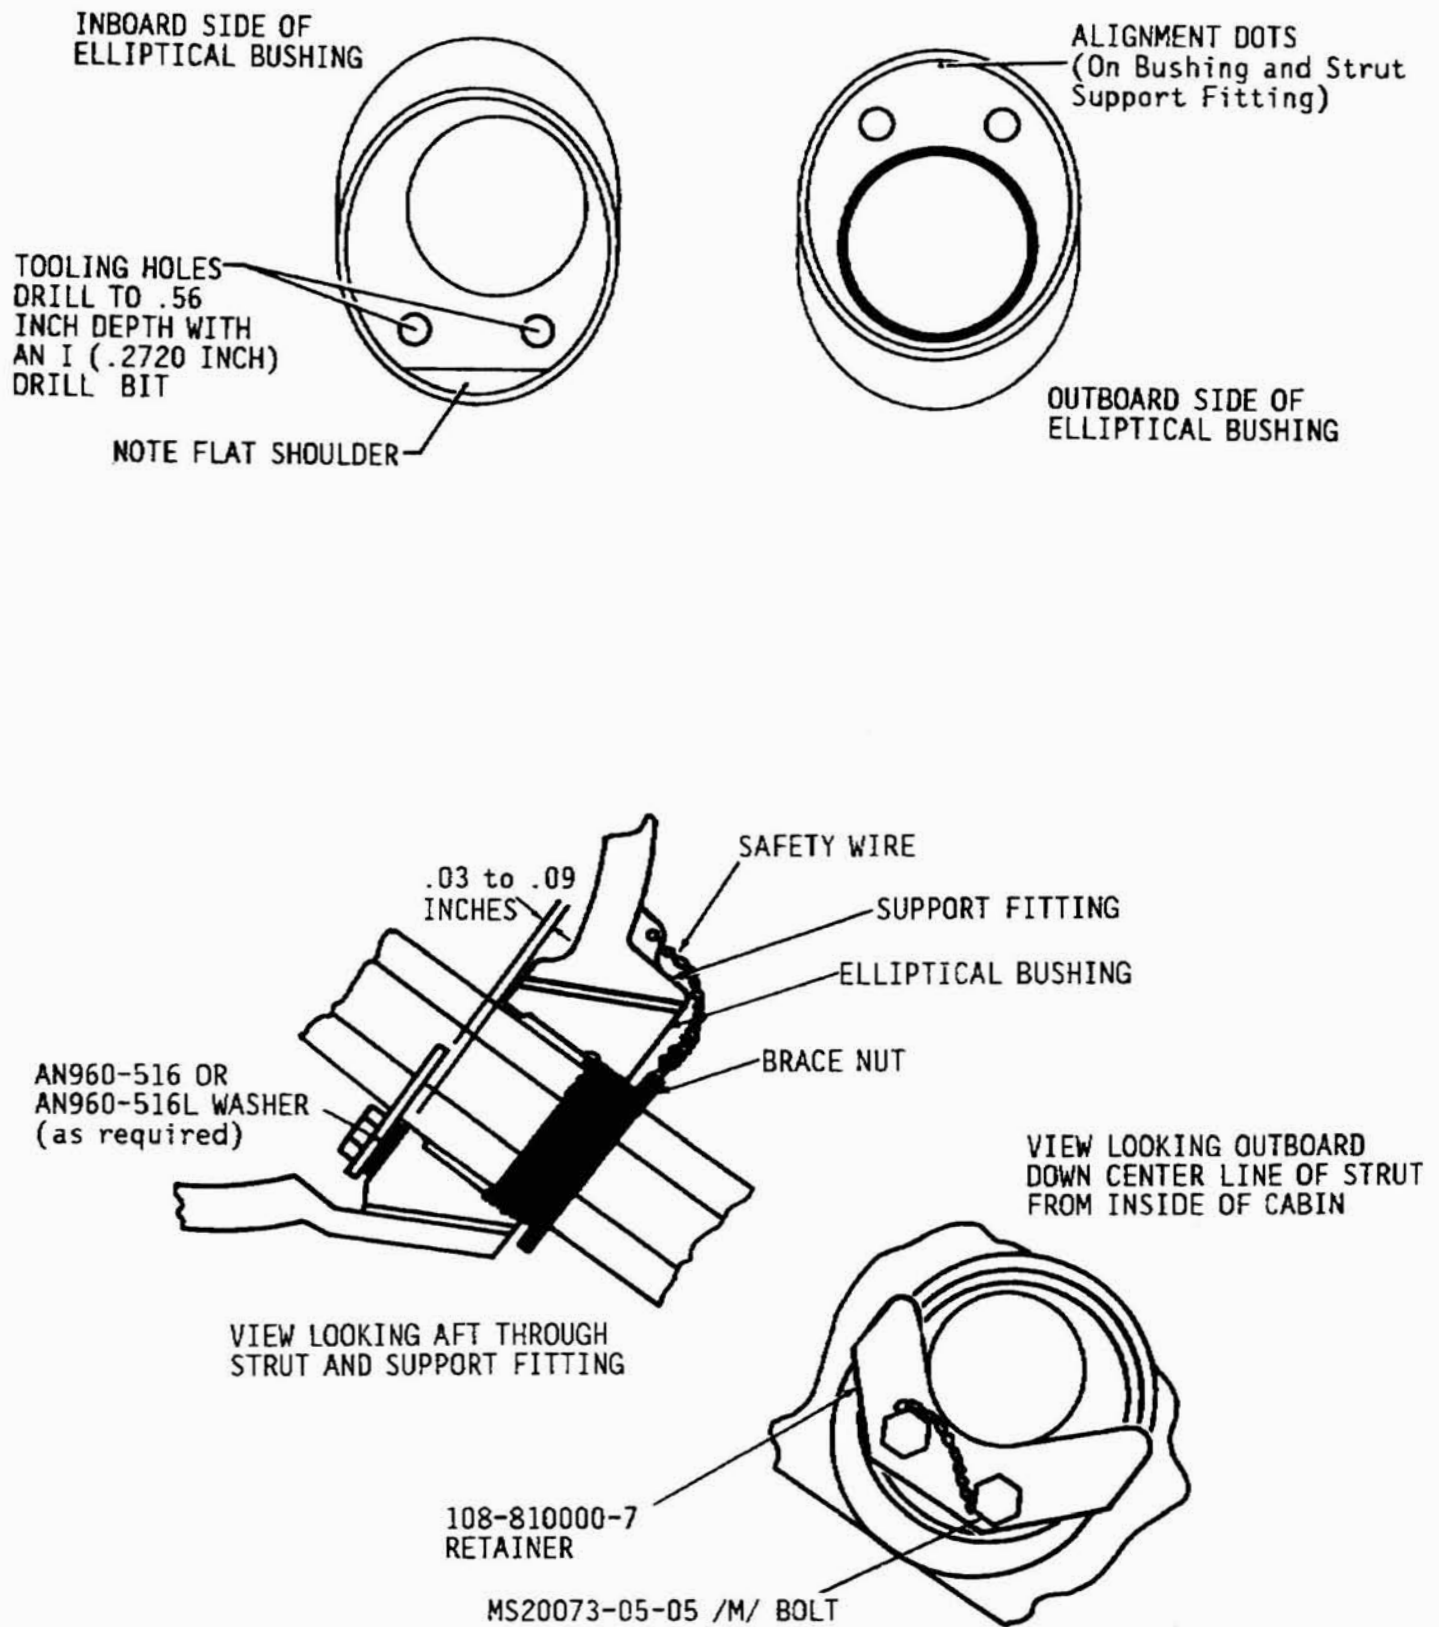
Inspect the condition of the Urethane coating on the elliptical bushing. If the coating is damaged, a new bushing will be required.

4. Install a new P/N 108-810020-3 retainer nut. Do not tighten until Step 5 has been accomplished. The single piece brace nut and collar (retainer nut) does not require bonding.
5. Prior to reinstallation of the landing gear struts, check to see if BEECHCRAFT Service Bulletin No. 2003 has been accomplished previously. Service Bulletin No. 2003 modifies the elliptical bushing (Fig 2) by the addition of the bushing retainer contained in Kit No. 77-8003-1 S. If this modification has not been accomplished, remove the elliptical bushings from the fuselage fittings and perform the following:
  - a. Locate the two tooling holes in the inboard side of the elliptical bushing. Drill a .2720 inch diameter hole to a depth of .56 inch. Tap the holes to 5/16 - 24 thread, starting with a tapered tap and finishing with a bottoming tap as shown in Figure 2.

- b. When installing the retainer ensure that the alignment dots on the elliptical bushing and strut support fitting are aligned exactly. Using a spanner wrench, torque the P/N 108-810020-3 retainer nut (Fig.2) to 125-150 inch-pounds. Ensure that the alignment dots align after torquing. Safety the retainer nut.

In some cases, the retainer nut may contact the strut support fitting prior to reaching full torque. It is permissible to remove sufficient material from the edge of the strut support fitting to permit torquing the retainer nut.

- c. Install a P/N 108-810000-7 retainer as shown in Figure 2 using two P/N MS20073-05-05 /M/ bolts. Place P/N AN960-516 or P/N AN960-516L washers (obtain locally) between the bushing and retainer as required to maintain a spacing of .03 to .09 inch between the retainer and support fitting as shown in Figure 2. Torque the bolts to 56 - 78 inch-pounds and safety.

- d. Reinspect for .03 to .09 inch clearance between the retainer and support fitting.
