SERVICE BULLETIN

TITLE: FLIGHT CONTROLS - INSTALL FLAP INSPECTION ACCESS PANELS ON CERTAIN AERO CENTER PRODUCTS

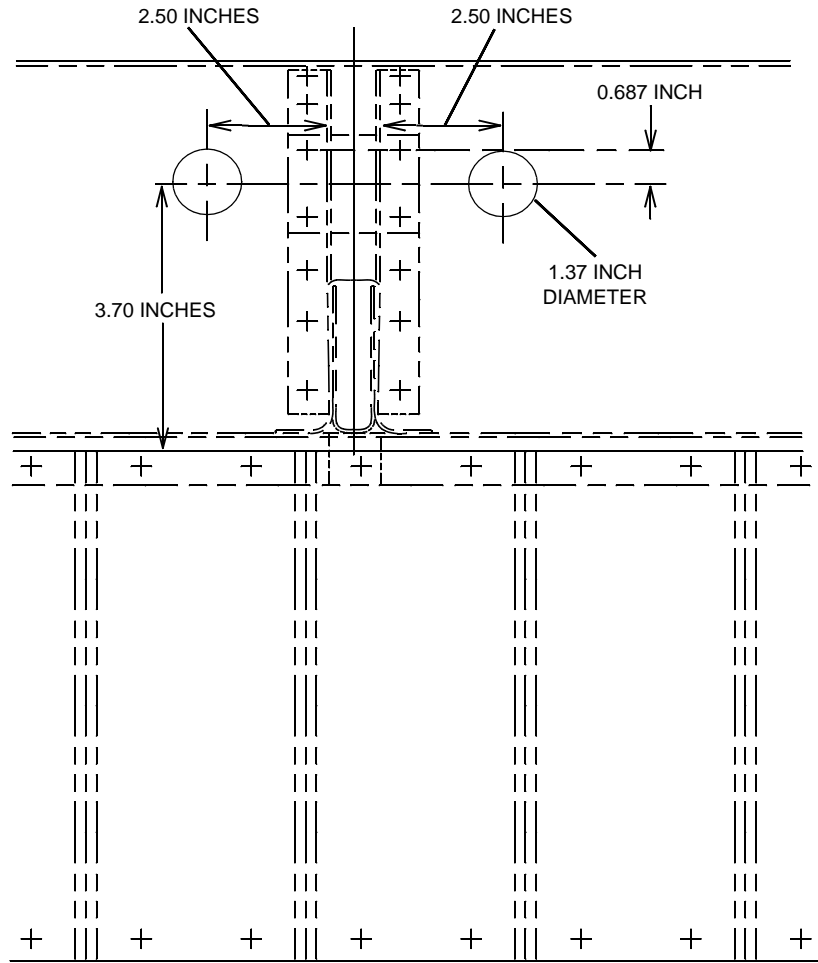
Figure 1

VIEW LOOKING DOWN ON TOP SURFACE OF FLAP
(INSTALLATION TYPICAL FOR ALL LOCATIONS ON AFFECTED MODELS)

Inspection Holes on Top of Flaps Installed Inboard and Outboard of Flap Hinge Points

- (2) Remove flaps. For Duchess airplanes, refer to Maintenance Manual Chapter 27-50-00; for Musketeer, Sport, Sundowner and Sierra airplanes, refer to Beechcraft Shop Manual, Section 3-21.
- (3) Pull and collar flap circuit breaker (if applicable) and install warning placards against reconnecting power.
- (4) Locate the areas on top of flaps where inspection holes are to be added on both sides of flap hinges. Refer to Figure 1.
 - (a) Duchess 76 requires six (6) holes in each flap.
 - (b) Musketeer, Sport, Sundowner and Sierra require four (4) holes in each flap.
- (5) Carefully lay out hole locations and drill the 1.375-inch holes.

- (12) Install patch plates P/N 132641-5G on all inspection holes created in Step (4) of this service bulletin.
- (13) Install flaps on airplane. For Duchess airplanes, refer to Maintenance Manual Chapter 27-50-00; for Musketeer, Sport, Sundowner and Sierra airplanes, refer to Beechcraft Shop Manual, Section 3-21.
- (14) Reset flap circuit breaker if previously opened and remove warning placards.
