Model: 23

No. 3

Issued: December, 1962

SUBJECT: ENGINE BREATHER LINE MODIFICATION

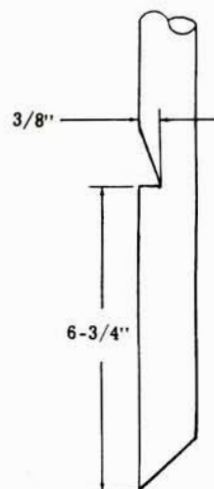
REASON FOR MODIFICATION: To prevent engine breather line stoppage due to freezing in extremely cold weather.

Make a cut in the engine breather line, 6-3/4 inches up from the bottom of the tube and 3/8 inch deep as shown in the illustration.

The cut should be made on the forward side of the breather line in order to take advantage of the direct engine heat.

After the cut has been made, crimp the tube on the top side of the cut as illustrated.
