# Beechcraft SERVICE BULLETIN

Model: 23

No. 5

**SUBJECT:** INSTALLATION OF AN21-10 BOLTS IN AILERON CABLE-CHAIN CONNECTING LINKS.

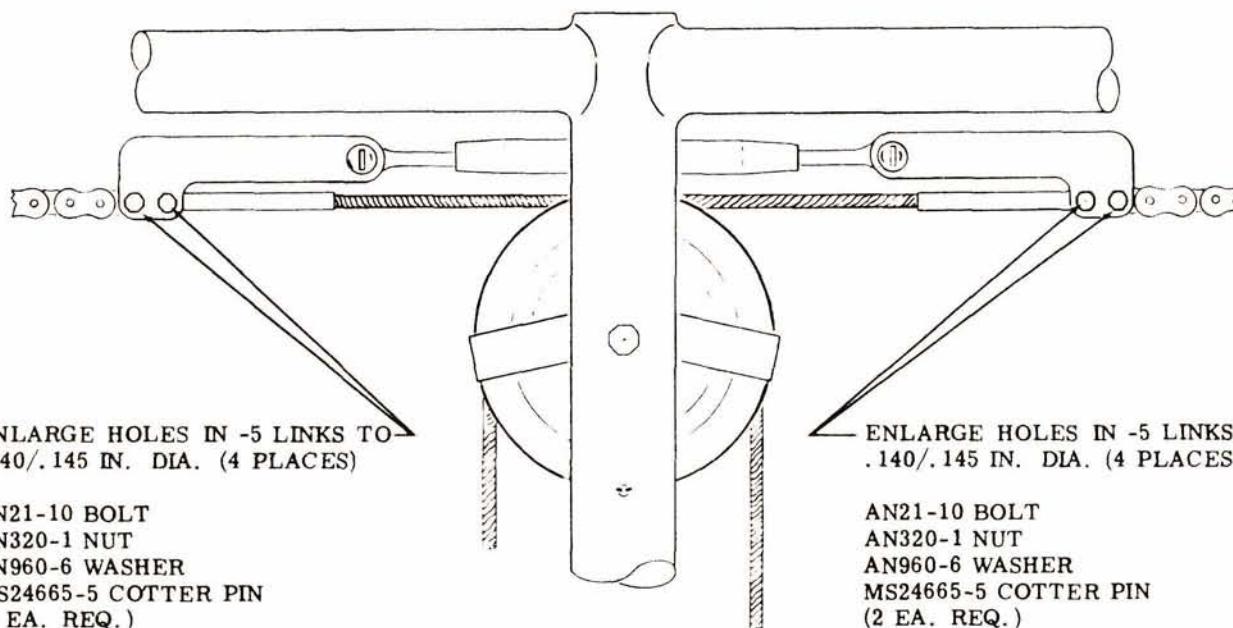
1. Locate the two pairs of 169-524040-5 aileron cable-chain connecting links on the control column crossbar

behind the instrument panel. (See illustration).

2. Working on either the right hand or left hand pair of links, remove the cotter pin from the cable retaining pin and carefully remove the retaining pin from ONE CONNECTING LINK ONLY. Exercise care to avoid releasing the cable terminal.

3. Enlarge the hole from which the retaining pin was removed to .140/.145-inch diameter.

4. Insert an AN21-10 bolt into the .140/.145-inch diameter hole and engage the cable terminal with the bolt while removing the retaining pin from the terminal and opposite link. Again make certain that the cable terminal is not released.

5. Drill out the retaining pin hole in the opposite link to .140/.145-inch diameter and insert the AN21-10 bolt.

6. Secure the AN21-10 bolt with an AN320-1 nut, AN960-6 washer, and an MS24665-5 cotter pin.

7. Replace the pin securing the aileron control chain with an AN21-10 bolt by employing the same procedure described above.

8. Follow the preceding instructions for rework of the opposite pair of aileron cable-chain connecting links.
