# Beechcraft SERVICE BULLETIN

No. 63-4

Issued: September 20, 1963

**SUBJECT:** INSTALLATION OF IMPROVED THROTTLE AND MIXTURE CONTROL HOUSING CLAMPS, REINFORCEMENT OF ENGINE CONTROL MOUNTING BRACKET, AND CHANGE OF THROTTLE CONTROL RIGGING.

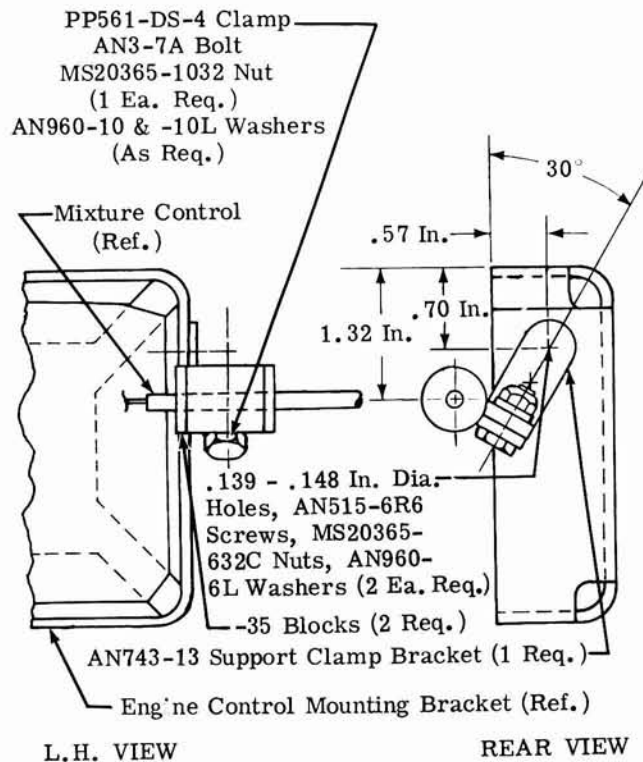
Figure 1

**REASON FOR CHANGE:** To insure positive retention of the throttle and mixture control housings, to prevent possible breakage of the engine control mounting bracket, and to improve throttle rigging.

1. Remove the clamp and attaching parts securing the mixture control housing at the carburetor.
2. Position an AN743-13 support clamp bracket on the aft left hand side of the engine control mounting bracket as shown in Figure 1. Drill a .139 - .148 inch diameter hole in the engine control mounting bracket through the upper attaching hole in the AN743-13 bracket.
3. Attach the AN743-13 bracket to the engine control mounting bracket with an AN515-6R6 screw, MS20365-632C nut, and an AN960-6L washer. Do not tighten the

7. Secure the -35 blocks and the PP561-DS-4 clamp to the AN743-13 bracket with the AN3-7A bolt and an MS20365-1032 nut. Use AN960-10 and AN960-10L washers as required to obtain the 1.32 inch dimension shown in Figure 1.
