Beechcraft SERVICE BULLETIN

No. 64-1

SUBJECT: MODIFICATION OF HEATER/MUFFLER SHROUD AT THE EXHAUST OUTLET TUBE.

AIRCRAFT AFFECTED: All Model 23 aircraft prior to M-555 except M-1.

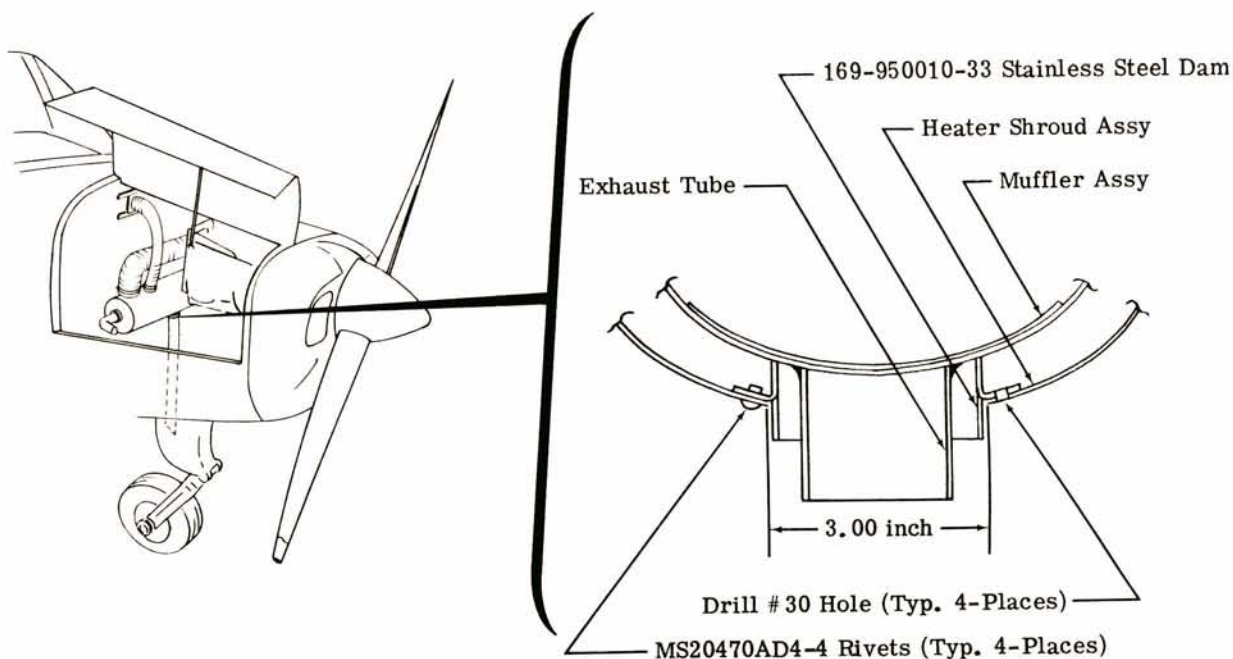
REASON FOR CHANGE: To eliminate the possibility of engine exhaust (carbon monoxide) entering the heater system.

3. Modify the heater shroud at the muffler exhaust outlet by enlarging the diameter of the exhaust outlet tube hole to a 3.00 inch dimension. (See illustration.)

4. Position the stainless steel dam P/N 169-950010-33 per illustration - then locate and drill the four rivet holes using a #30 wire drill (drill hole size is .128). Install the four MS 20470 AD4-4 rivets.
