SUBJECT: INSPECTION OF THE FUSELAGE STRUCTURE AT THE AFT BULKHEAD.

AIRCRAFT AFFECTED: BEECHCRAFT Musketeer Model 23 Airplanes, Export and Domestic, that:

REASON FOR CHANGE: To inspect and/or add structural reinforcement to the aft fuselage section and aft bulkhead.

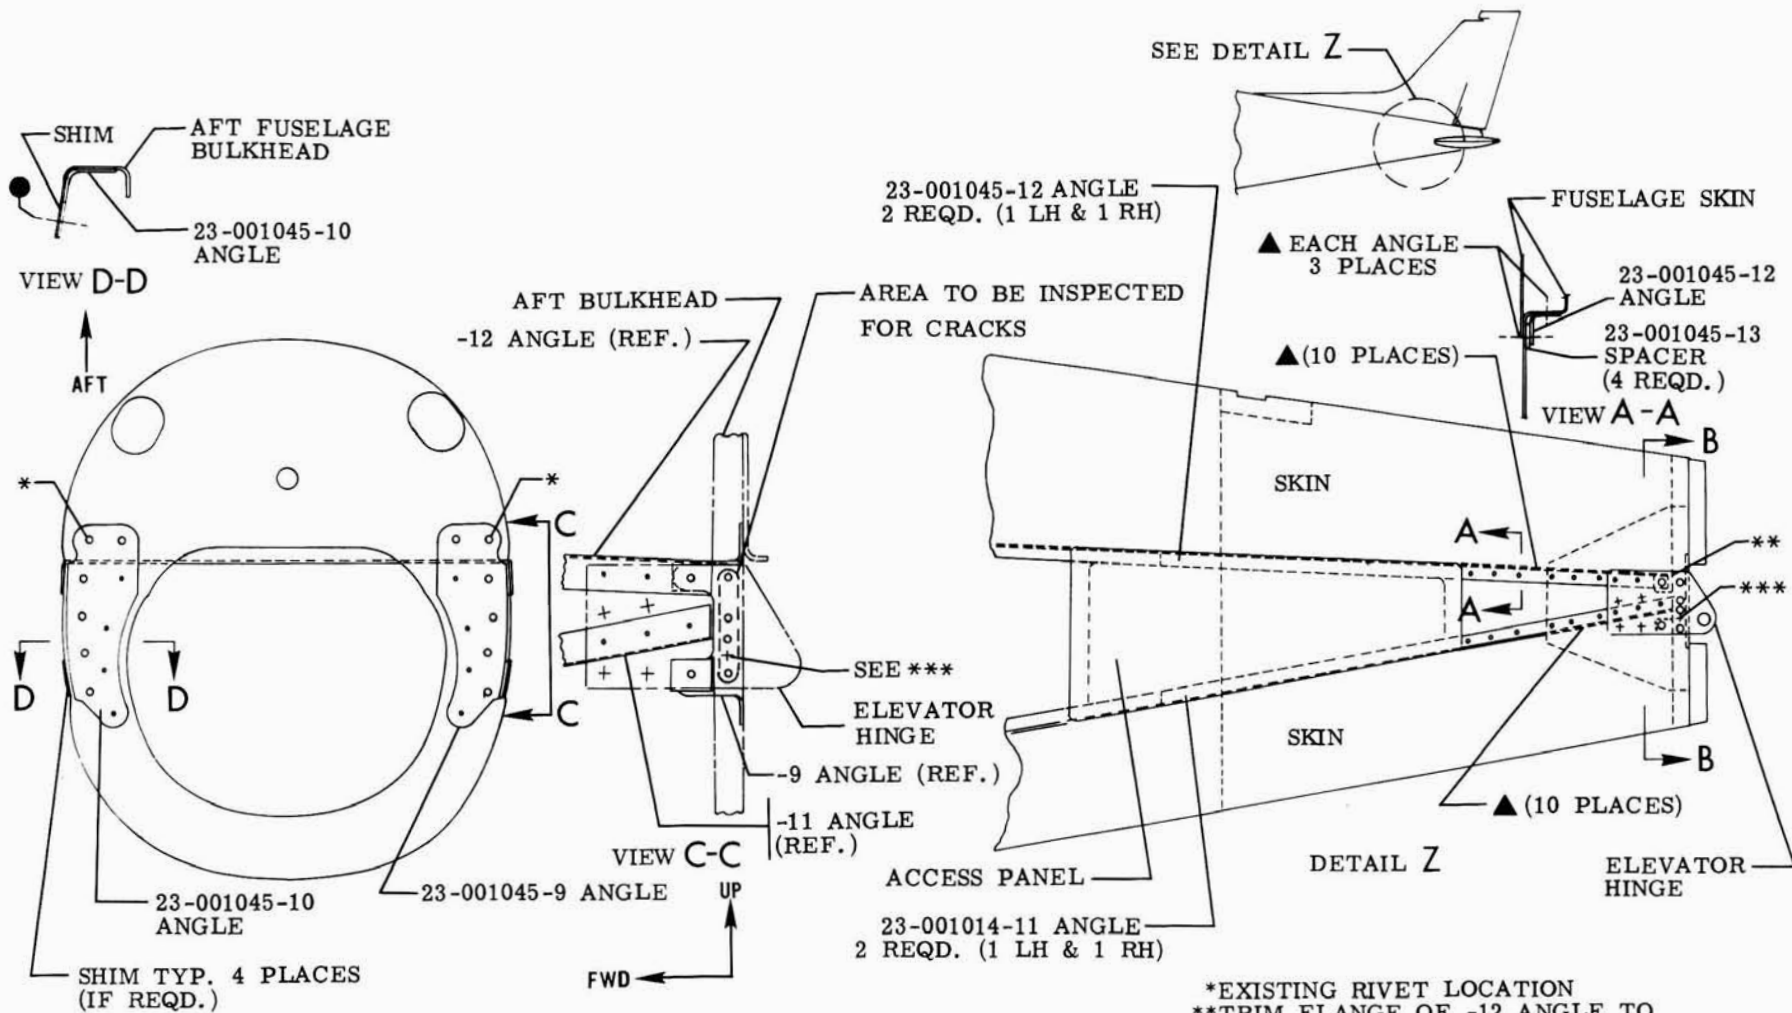
DESCRIPTION: This bulletin is issued to inform owners of BEECHCRAFT Musketeers who were unable to participate in the Musketeer Model 23 factory up-dating and modification program, or who have not installed Kit 23-10SR or Kit 23-11SR, of an inspection and/or modification repair of the aft fuselage structure at the aft bulkhead. This repair is recommended to prevent the possibility of the development of cracks in the aft bulkhead flange, where the five rivets attaching the stabilator hinges are installed (see illustration).

To perform the inspection remove the two access panels, one on each side of the aft fuselage, just forward of the stabilator and check for cracks progressing outward from the five (5) rivet butts in the aft bulkhead flange at the stabilator hinge bracket tie-in. If cracks are found in the bulkhead flange at the rivet butt it is recommended that a repair be made in accordance with Manual CAM 18 for in-field repair.

Repair of bulkhead cracks shall not interfere with the installation of the structural reinforcement parts. If interference exists the aft bulkhead should be replaced.

6. Locate the new angles on the aft bulkhead. Drill the angle to match the two existing rivet locations on the bulkhead. Drill through the bulkhead flange, hinge and fuselage skin five places to match the angle. Drill the remaining locations as required to match the locations in the angle. Drill all holes as required to full size and rivet the angles and spacers with rivets as noted. (Use shims under angle tabs if required.)

*EXISTING RIVET LOCATION
 **TRIM FLANGE OF -12 ANGLE TO CLEAR -9 & -10 ANGLE
 ***REMOVE EXISTING RIVET THIS LOCATION & ADD A FLUSH RIVET THRU HINGE, SKIN & BULKHEAD. THIS RIVET DOES NOT FASTEN THE 23-001045-9 OR 23-001045-10 ANGLE.
