Beechcraft SERVICE BULLETIN

No. 64-3

SUBJECT: CHECKING THE STABILATOR FOR PLAY

AIRCRAFT AFFECTED: 23 (M-1 thru M-119).

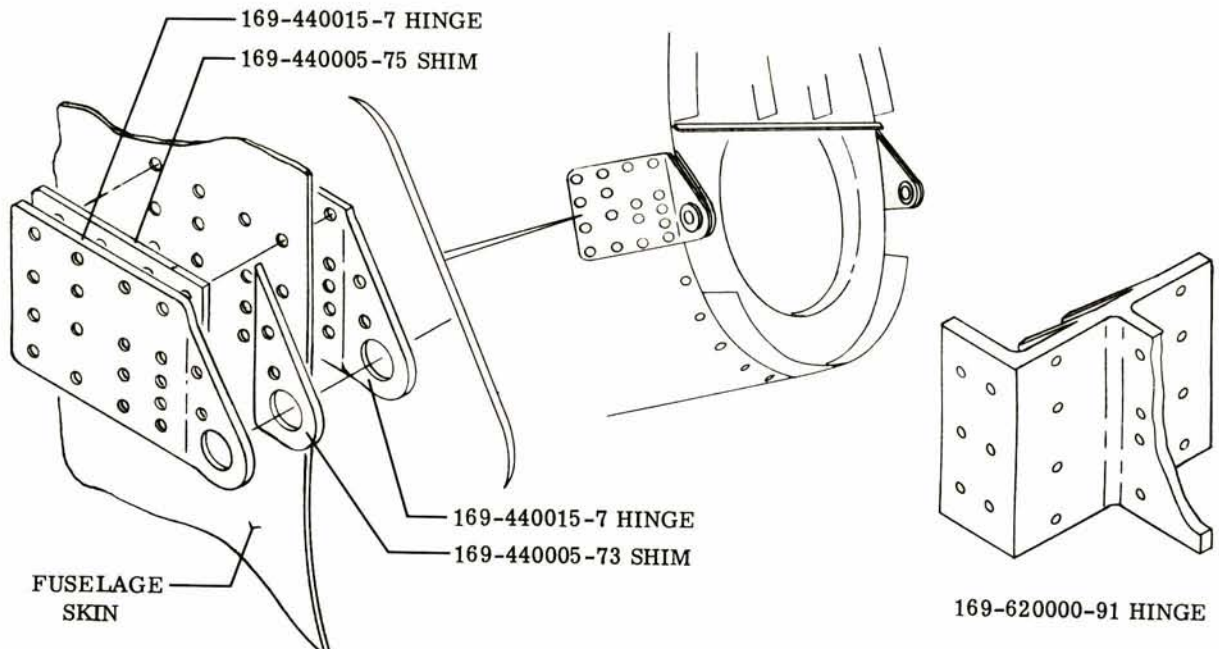
REASON FOR CHANGE: To prevent the occurrence of excessive play in stabilator tips.

Early Musketeers (serials M-1 thru M-119) should be checked for the extent of play at the stabilator tips. Excessive play is an indication of worn bearings or extrusions. If such play is in evidence, the stabilator should then be removed from the airplane, and the distance between the outside diameter of the bolt and the

c. Rivet the hinges and shim to the tail section with MS20470AD5-8 rivets as shown in the illustration.

d. Using a size 30 drill and taking care to observe the spacing and edge distances as established by standard aircraft repair practices, drill two holes in the hinges and in the 169-440005-73 shim at approximately the location shown in the illustration. Countersink the holes in each hinge so that the attaching rivets will be flush upon installation.

spar with a size 21 drill to match the rivet pattern of the hinge shown in the illustration, taking care to observe the spacing and edge distances as established by standard aircraft repair practices. It should be noted that the row of rivets that fitted into the pilot holes adjacent to each slot is omitted in the installation of the heavier hinges.
