# Beechcraft SERVICE BULLETIN

No. 66-48

**SUBJECT:** TORQUING AND SAFETYING THE FUEL STRAINER (GAS-KOLATOR) RETAINING BOLT

**AIRCRAFT AFFECTED:** All BEECHCRAFT Model 23, A23 and A23A Musketeers, prior to M-976; all Model A23-19 Musketeer Sport III's, serials MB-1 through MB-119; all Model A23-24 Musketeer Super III's, serials MA-1 through MA-93.

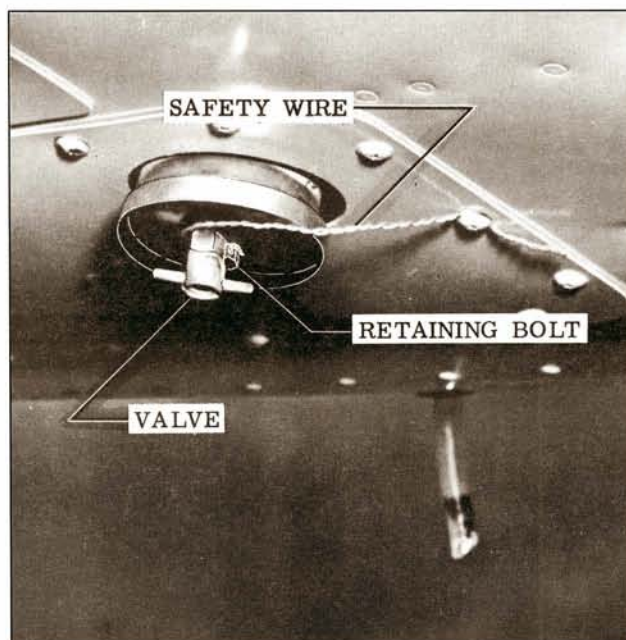
**REASON FOR CHANGE:** To insure that a fuel leak cannot develop in the affected area.

**DESCRIPTION:** Owners of the BEECHCRAFT Musketeers noted above should be sure that the retaining bolt in the fuel strainer is installed with the proper bolt torque, 25 inch-pounds, as stamped on the strainer.

The retaining bolt must also be safetied to the fuselage (rather than, for example, to the strainer valve), as shown in the accompanying photograph.
