Beechcraft SERVICE BULLETIN

No. 66-55

REV. 1

SUBJECT: IMPROVED METHOD OF ATTACHING ADF NOISE SUPPRESSOR CAPACITORS.

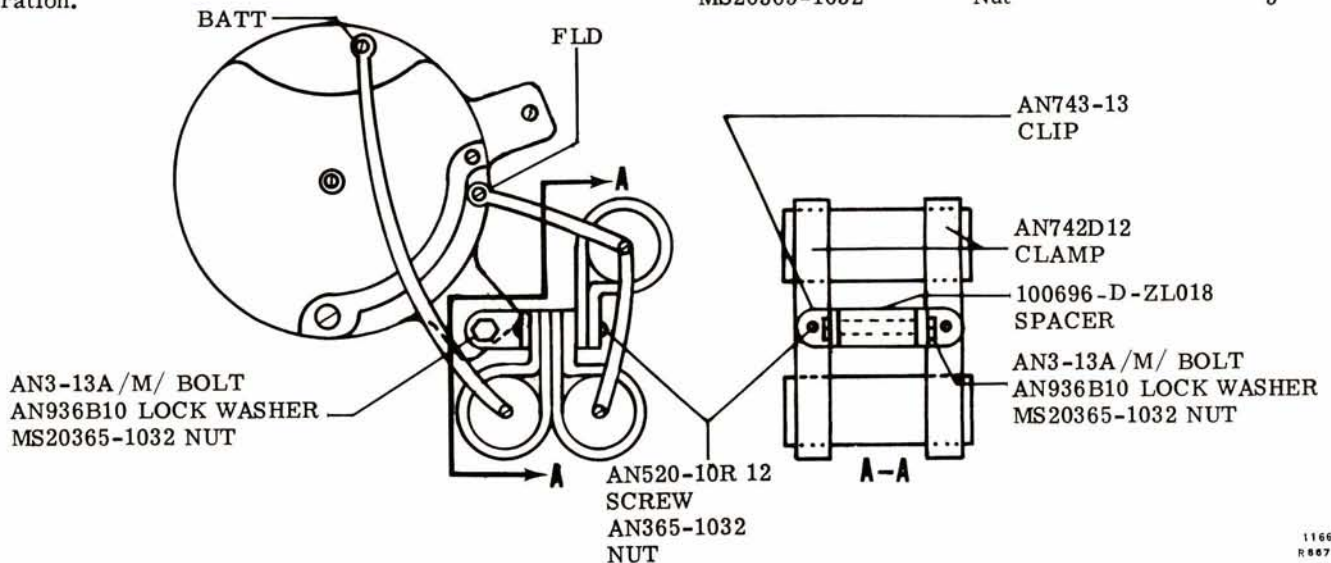
REASON FOR CHANGE: To insure that the noise suppressor capacitor bracket does not fail in service allowing the capacitors to fall into the throttle linkage.

DESCRIPTION: Remove the capacitor bracket, P/N 169-910003-11, from the engine crankcase adjacent to the alternator and assemble and install the capacitors, as illustrated. The wires to the battery and field terminals should be shortened as required to attain best noise suppression characteristics.
