# SERVICE INSTRUCTIONS

No. 0042-031, Rev. II  
ATA Code 53-40  
Recurring Inspection

**SUBJECT:** FUSELAGE - INSPECTION OF FORWARD WING ATTACH POINT

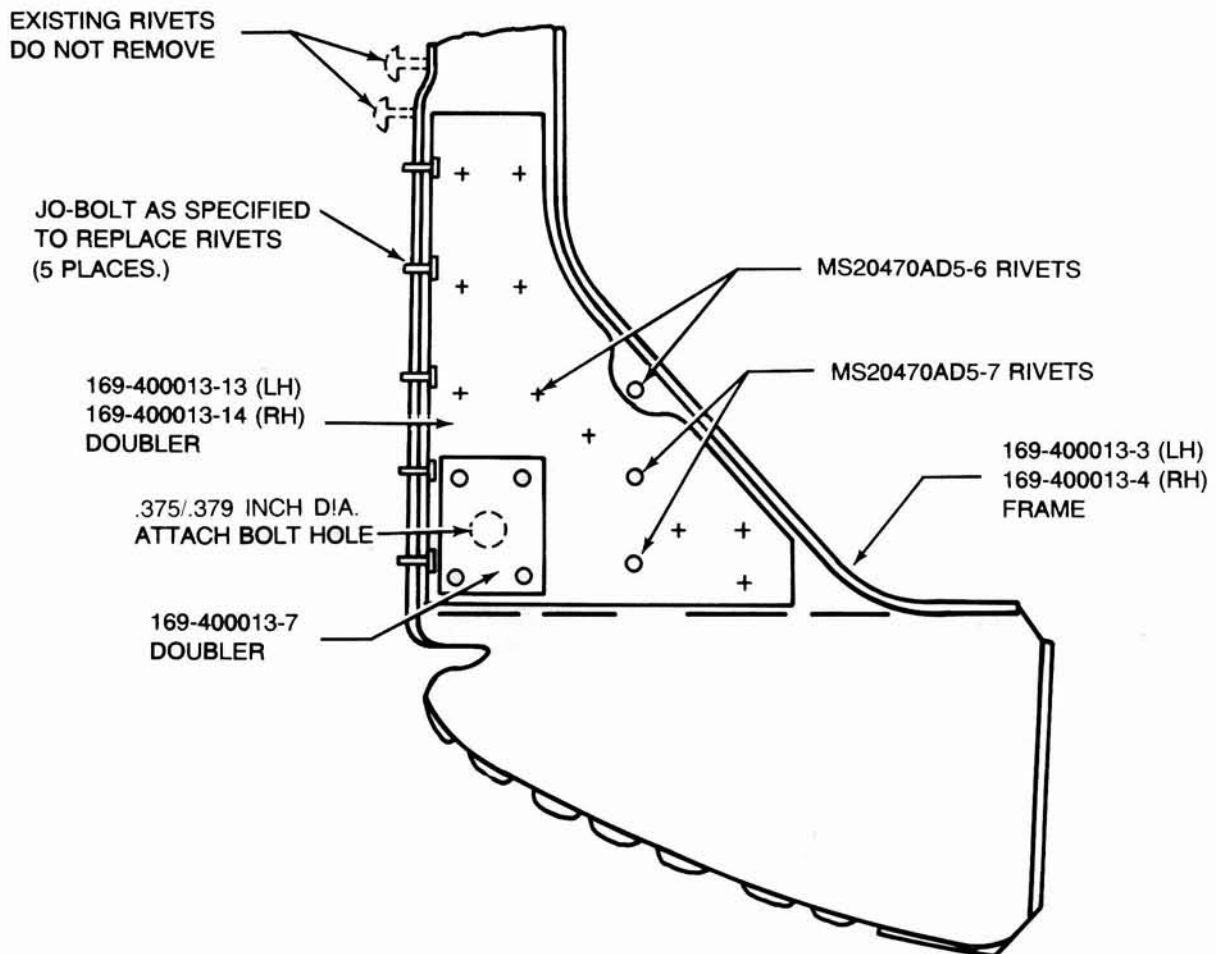
Figure 1.

- a. Remove the pilot and copilot seats, forward carpets and upholstery panels below the cabin doors.
- b. At each 100 hour, annual or periodic inspection, visually inspect for radial or circumferential cracks around the wing attach bolt head or nut in the following parts: P/N 169-400013-3 (LH) frame, P/N 169-400013-4 (RH) frame, P/N 169-400013-5 (LH) bracket, P/N 169-400013-6 (RH) bracket and the following doublers, if installed: P/N 169-400013-7 (LH and RH), P/N 169-400013-13 (LH), P/N 169-400013-14 (RH), 169-400013-45 (LH) and P/N 169-400013-46 (RH).

Each 500 hours after the accumulation of 2000 hours in service (i.e. at 2000, 2500, 3000 hrs, etc.), this inspection is to be accomplished by loosening the nut on the attach bolt and inspecting for possible cracks in the above parts using dye penetrant procedures as outlined in AC43.13-1A.

3. Drill out the three rivets through the bracket and frame, and the five rivets through the outboard flange of the bracket and the fuselage skin (See Figures 1 and 2), and discard the bracket.

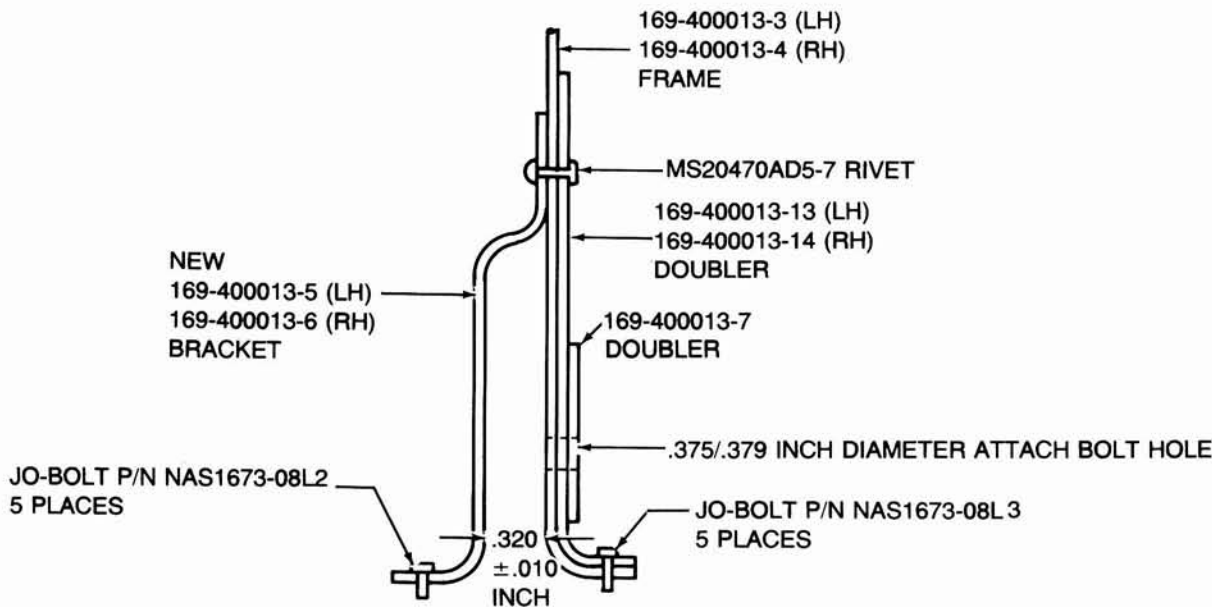
**Figure 2.**

169-400013-1 (LH), 169-100013-2 (RH) FRAME ASSEMBLY
