# SERVICE INSTRUCTIONS

No. 0042-031, Rev. II  
ATA Code 53-40  
Recurring Inspection

**SUBJECT:** FUSELAGE - INSPECTION OF FORWARD WING ATTACH POINT

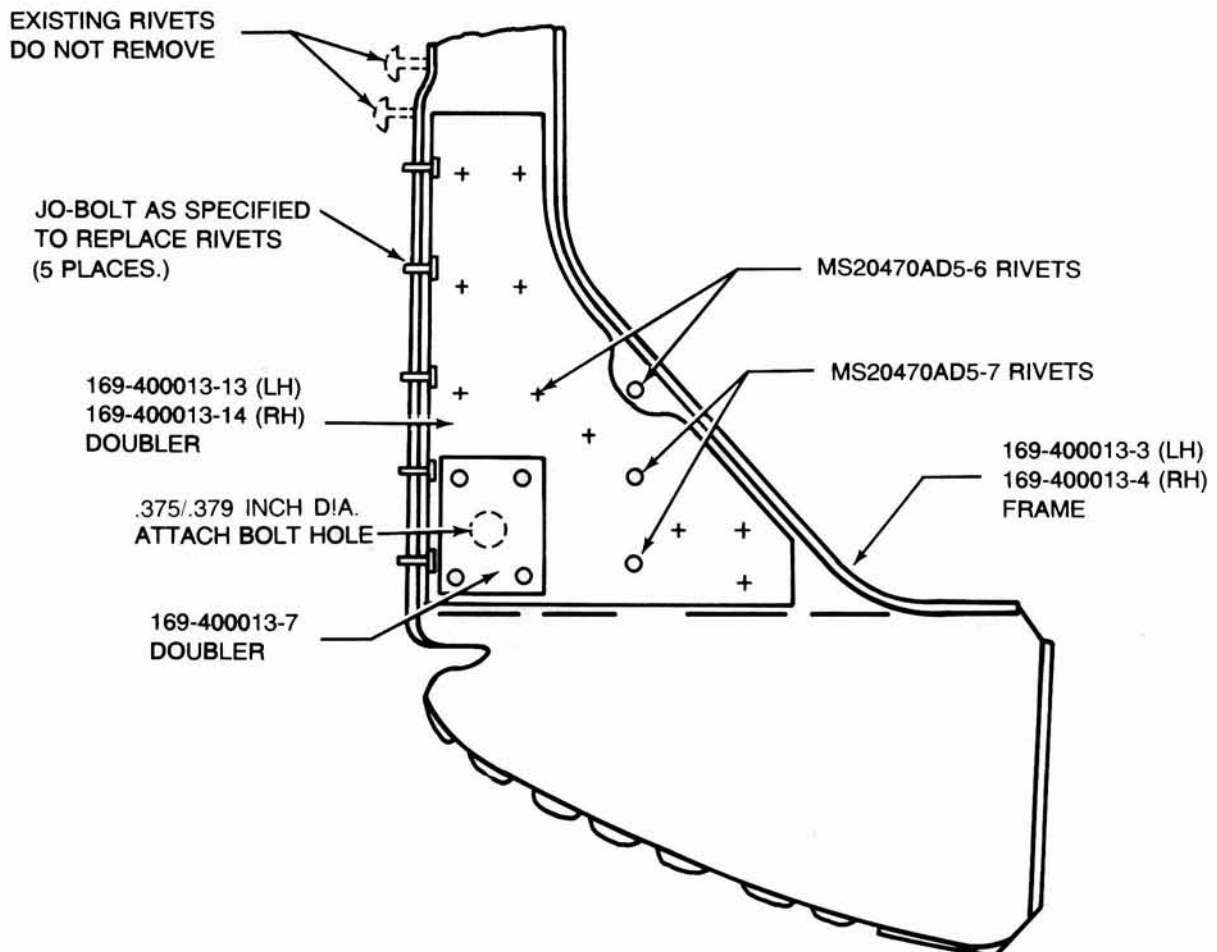
Figure 1.

- a. Remove the pilot and copilot seats, forward carpets and upholstery panels below the cabin doors.
- b. At each 100 hour, annual or periodic inspection, visually inspect for radial or circumferential cracks around the wing attach bolt head or nut in the following parts: P/N 169-400013-3 (LH) frame, P/N 169-400013-4 (RH) frame, P/N 169-400013-5 (LH) bracket, P/N 169-400013-6 (RH) bracket and the following doublers, if installed: P/N 169-400013-7 (LH and RH), P/N 169-400013-13 (LH), P/N 169-400013-14 (RH), 169-400013-45 (LH) and P/N 169-400013-46 (RH).

3. Drill out the three rivets through the bracket and frame, and the five rivets through the outboard flange of the bracket and the fuselage skin (See Figures 1 and 2), and discard the bracket.

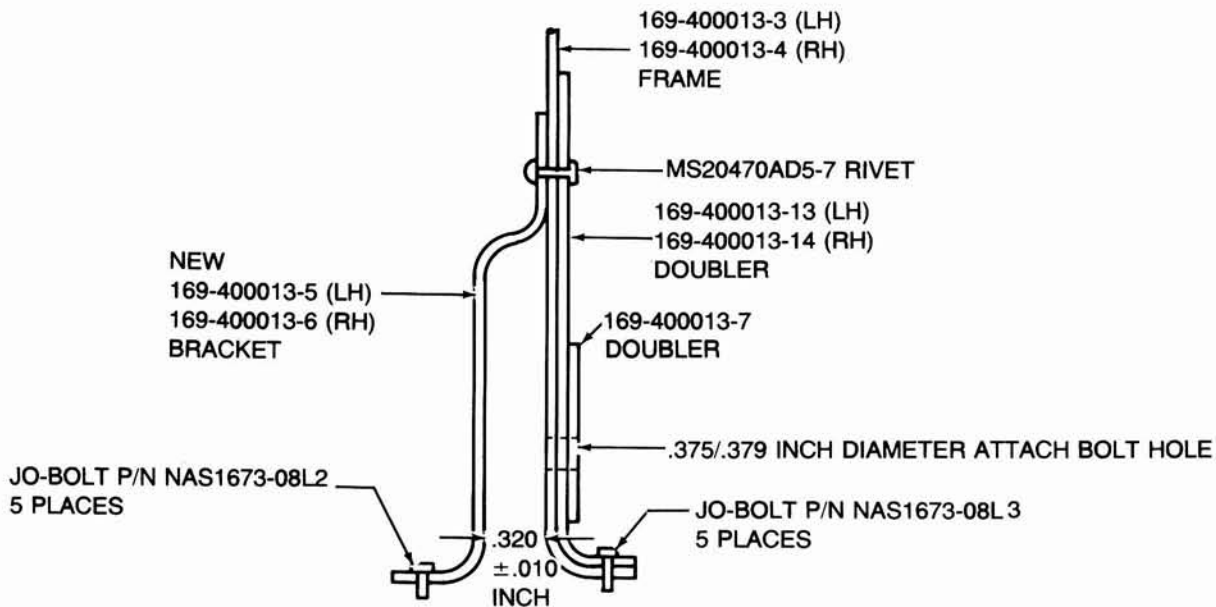
**Figure 2.**

169-400013-1 (LH), 169-100013-2 (RH) FRAME ASSEMBLY
