SUBJECT: POWER PLANT, INSPECTION OF CONSTANT SPEED PROPELLER INSTALLATION

AIRCRAFT AFFECTED: BEECHCRAFT Musketeers, Model A23-24, serials MA-185, MA-188 through MA-192, MA-195 through MA-199, MA-201, MA-210, MA-212, MA-214 through MA-216, MA-219, MA-222, MA-227 through MA-230, MA-236, MA-240, MA-243, MA-246 through MA-248, MA-254, MA-259, MA-260, MA-263, MA-266 through MA-268, MA-280, MA-283, MA-287 through MA-295, MA-297, MA-298, MA-301 through MA-304, MA-306, MA-310 through MA-312, MA-314 through MA-316, MA-318, MA-326, MA-329 through MA-331, MA-334, which are equipped with constant speed propeller P/N 2D34C8/78FB-1.5

Service Instructions No. 0146-240

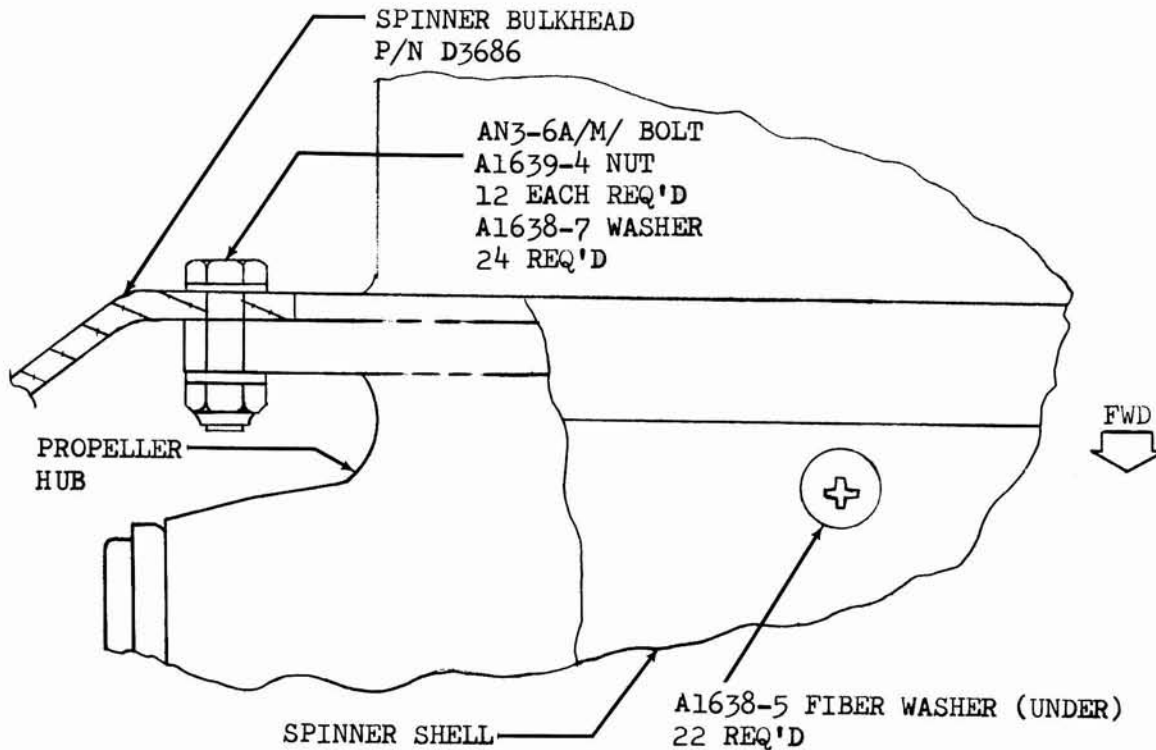
DESCRIPTION: On BEECHCRAFT Musketeers, model and serials noted above, it is recommended that the propeller spinner installation be inspected to determine that fiber washers are not installed on any of the bolts fastening the spinner bulkhead to the propeller hub, and that no washers are installed between the bulkhead and hub.

1. Remove the spinner and remove the AN3-6A/M/ bolts attaching the spinner bulkhead to the propeller hub to determine if fiber washers have been used on the bolts or if washers have been installed between the hub and the bulkhead. (See the illustration below for a picture of the proper installation.) If there are no washers installed between the hub and the bulkhead, and if no fiber washers have been used, no further action is necessary, and the bulkhead and spinner may be reinstalled.

2. If washers are installed between the hub and bulkhead, or if fiber washers have been used on the AN3-6A/M/ bolts, inspect the bulkhead for elongation of the mounting bolt holes and the bolts for wear (removing the propeller, if necessary). If the holes are not elongated, or if elongation does not exceed .030 inch and the bolts are not worn, no further action is necessary, and the propeller and the bulkhead and spinner assembly

may be reinstalled, making sure that no washers are used between the hub and the bulkhead and that no fiber washers are used on the bulkhead attach bolts.

3. If the mounting holes in the bulkhead are elongated more than .030 inch, it will be necessary to replace the bulkhead, P/N D3686, with a new bulkhead of the same part number.
