No. 0253-151

**SUBJECT:** AILERON AND AILERON TAB CONTROLS, INSTALLATION OF AN IMPROVED AILERON CENTERING CABLE

**AIRCRAFT AFFECTED:** BEECHCRAFT Musketeer Model A23A, and B23, serials M-963 through M-1284; Model A23-24, serials MA-28 through MA-361 and MA-368; Model A23-19 and 19A, serials MB-1 through MB-461.

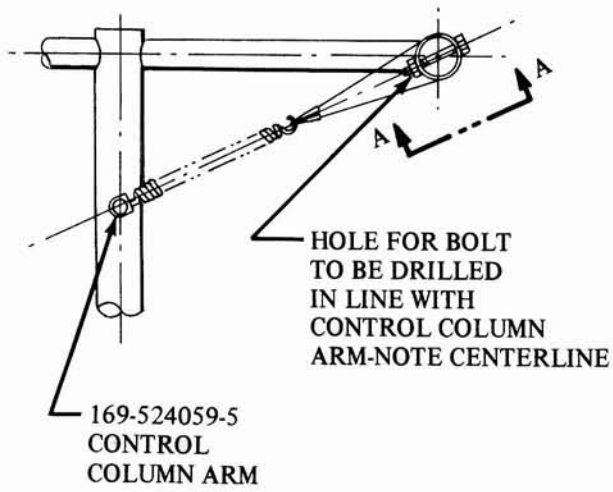
FIGURE 1

The aileron centering cable assembly for current production BEECHCRAFT Musketeers incorporates a longer aileron centering cable assembly, P/N 169-524059-7, and an improved method of installation. When it is necessary to replace the existing aileron centering cable on the aircraft noted above, the longer cable assembly, P/N 169-524059-7, may be used as a replacement for the original cable assembly, P/N 169-524059-3. This modification may be accomplished as follows:

1. Drill a .250/.254 hole in the control column to accommodate the AN4-16A bolt used in the new 169-524059-7 cable assembly. The hole should be 2.25 inches aft of the forward end of the control column tube

and drilled to align with the existing hole in the vertical control column when the wheel is in neutral as shown in figure 1.

2. Discard the 100942S0416-62 spring, and the 169-524000-35 clip and 169-524000-47 arms.

3. Install a new 169-524059-5 arm to the vertical control column in lieu of the 169-524000-35 clip.

4. Install the new 100942S0316-50 spring to the 169-524059-5 arm.

5. Install the new 169-524059-7 cable assembly and 169-524059-9 clip as set forth in the preceding instructions.
