No. 0384-24I, Rev. I
ATA Code 75-40

SUBJECT: POWER PLANT – MANIFOLD PRESSURE LINE MODIFICATION

EFFECTIVITY: BEEHCRAFT A23-24 and A24, serials MA-1 through MA-368 which are equipped with a constant speed propeller installation;
A24R, serials MC-2 through MC-95;

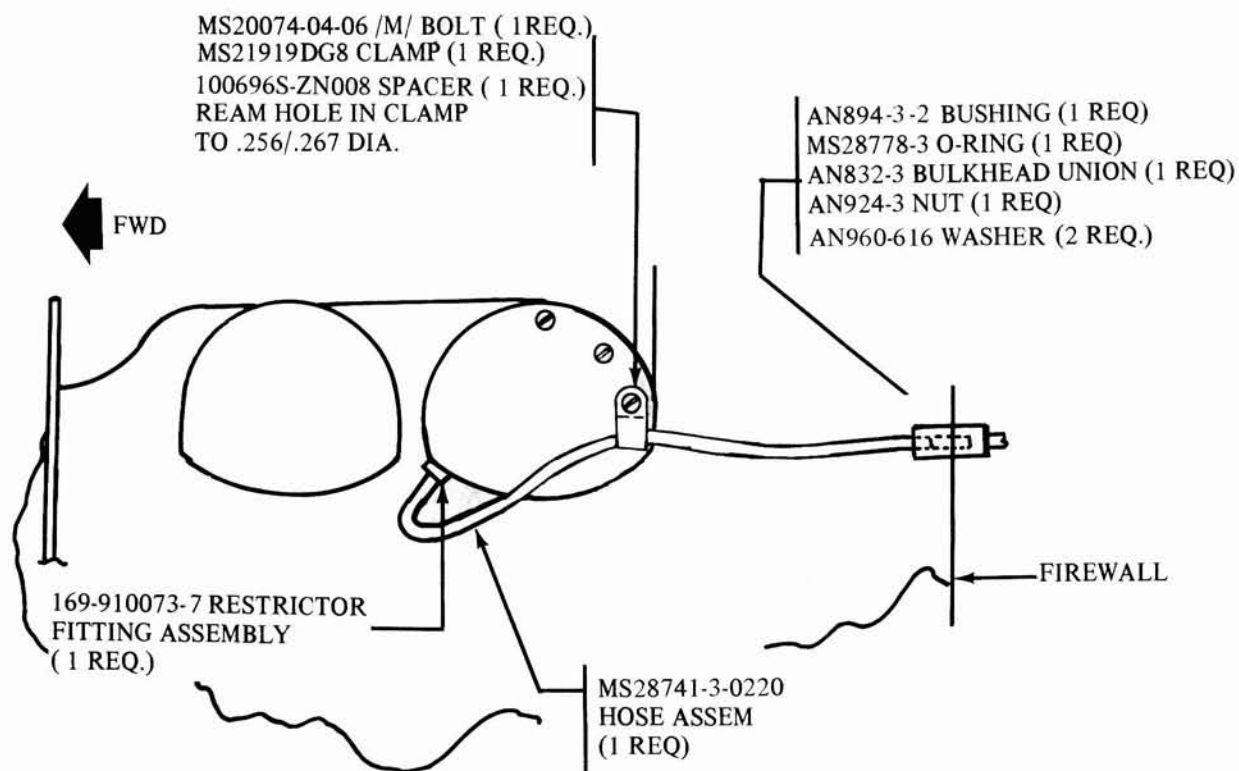
Manifold Pressure Line Modification.

REASON: To provide an improved manifold pressure line.

DESCRIPTION: The existing manifold pressure line is to be removed and discarded and replaced with a new hose assembly. Aircraft on which the P/N 169-910017-29 tube has been installed per the original issue of these Service Instructions must be modified by removing and discarding the tube and replacing it with the new hose assembly specified in these Service Instructions.

5. Drill one .44-inch diameter hole, centered .50-inch inboard and 5.38-inch above the center line of the hole where the firewall fittings were removed in step 4.

6. Install new, one each, AN832-3 bulkhead union, AN924-3 nut and two AN960-616 washers in the .44-inch diameter hole which was drilled in step 5. (See illustration.)

7. Install an SS51043 plug button in the open hole in the firewall where the fitting was removed.
8. Install one each, AN894-3-2 bushing and MS28778-3 O-ring on the aft side of the bulkhead union and connect the manifold pressure line aft of the firewall to the bushing. Torque the line nut to 90 to 100 inch-pounds.

9. Install the new MS28741-3-0220 hose assembly between the fitting on the aft left engine cylinder and the firewall fitting per the illustration. Torque these fittings to 70 to 100 inch-pounds.

10. Ream the attaching hole in an MS21919DG8 clamp to .256/.267 inch diameter.
11. Remove the existing aft left cylinder rocker arm cover screw as shown in the illustration and install the clamp on the rocker arm cover with a 100696S-ZN008 spacer and an MS20074-04-06 /M/ bolt. Torque this bolt to 50 to 70 inch-pounds.
