Beechcraft CLASS I SERVICE INSTRUCTIONS

No. 0415-161
ATA Code 27-50

SUBJECT: FLAP MECHANISM, ELECTRIC FLAP SYSTEM MODIFICATION

AIRCRAFT AFFECTED: BEEHCRAFT Musketeer, Model A24R, serials MC-3 through MC-70 except MC-22, MC-23, MC-39, MC-43, MC-63 and MC-64; Model A24, serial MA-368; Model C23, serials M-1286 and M-1300; Model B19, serials MB-490, MB-495 and MB-496 which are equipped with the optional electric flap installation.

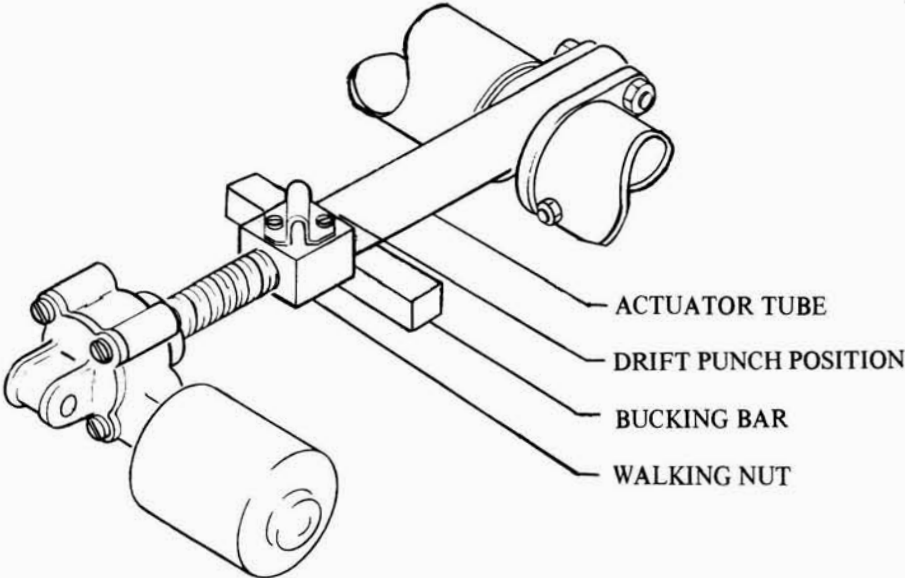
REASON FOR CHANGE: To preclude the possibility of inadvertant flap retraction.

DESCRIPTION: On the BEEHCRAFT Musketeers noted above it is necessary to form the actuator tube P/N 169-534071-15 at the forward end to prevent loosening of the tube during operation. Modification may be accomplished in the following manner:

1. Remove the third and fourth seat and floorboard under these seats when installed.
2. Remove the inspection plate over the flap actuator assembly.
3. Determine that the forward end of the actuator tube is fully engaged on the threaded end of the walking nut. The end of the tube should be butted against the aft surface of the walking nut.
4. Place a heavy bucking bar at the bottom forward edge of the actuator tube as shown in the illustration and with a 1/8 inch drift punch, form the edge of the tube down approximately 1/32 inch to prevent the threaded end of the walking nut on the screw-shaft from backing out of the tube.
