# SERVICE INSTRUCTIONS

0452-359, Rev. II  
ATA Code 24-30

**SUBJECT:** ELECTRICAL (ALTERNATOR) – INSTALLATION OF ALTERNATOR COOLING FAN

NUMBER ASM-8 ISSUED 5-30-72  
SUBJECT New Ventilating Fan Assembly  
APPLICATION All Belt Driven Aircraft Alternators Except ALV Series  
PAGE NO. 1 OF 2 PAGES

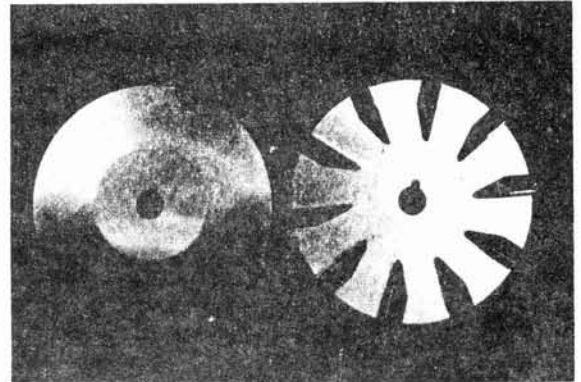
Figure 1

The new, two piece, unwelded construction ventilating fan, shown in Figure 1, consists of a thick gauge aluminum material ventilating fan and a thin gauge aluminum material backing plate. The backing plate is dished to provide vibration dampening when the fan and backing plate are properly assembled on the shaft and the retaining nut is torqued to the proper specification.
