SERVICE INSTRUCTIONS

No. 0465-202, Rev. II
ATA Code 32-10

SUBJECT: LANDING GEAR - MODIFICATION OF HOUSING INSTALLATION.

EFFECTIVITY: BEECHCRAFT A23-19, 19A, M19A, and B19, serials MB-1 through MB-520;
Sport B19, serials MB-521 through MB-536;
23, A23, A23A, B23, and C23, serials M-2 through M-1361;
Sundowner C23, serials M-1362 through M-1392;
A23-24 and A24, serials MA-1 through MA-368.

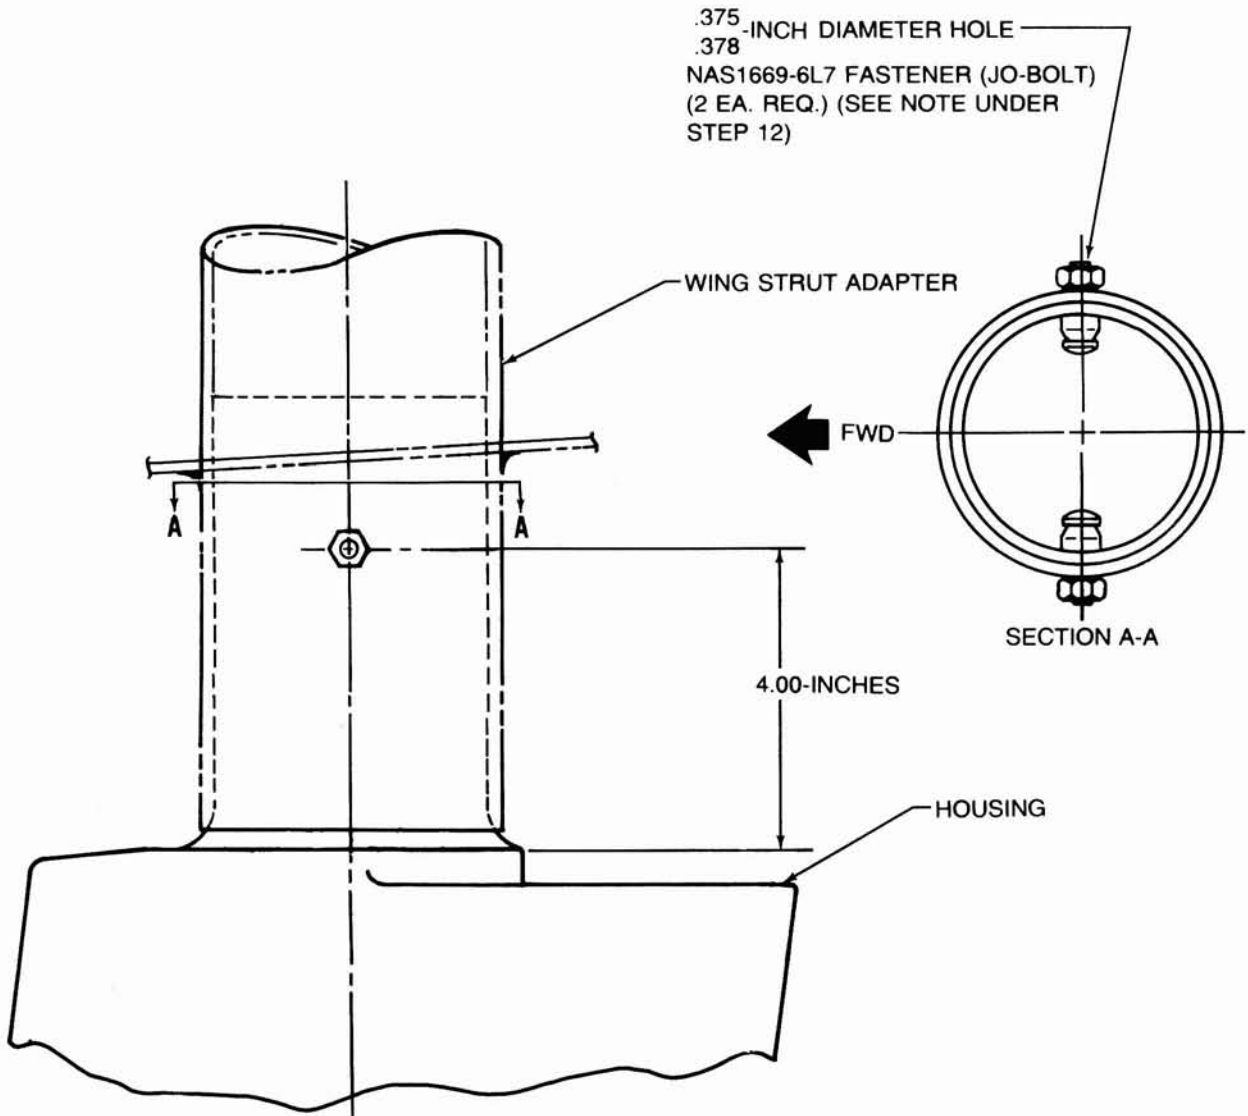
Modification Of Main Landing Gear Housing Installation

6. On the inboard and outboard sides of each wing strut adapter, locate a hole to be drilled through the adapter and housing as shown in the illustration. Drill the holes slightly undersize, then ream to .375 to .378-inch diameter.

12. Align the newly drilled holes in each adapter and housing and attach each housing to the adapter with two NAS1669-6L7 blind fasteners (Jo-Bolts) as shown in the illustration.

Oversize or slightly elongated holes may be reamed to .3905/.3935 inch diameter and NAS1751-6L7 Jo-Bolts may be installed. If holes cannot be reamed to this diameter in order to eliminate oversize or elongated holes, new holes may be located and drilled 1.25 inch lower than the existing holes. The new holes should be reamed to .375/.378 inch diameter and NAS1669-6L7 Jo-Bolts installed. Jo-Bolts must be directly opposite each other and must be parallel to the main spar. The Jo-Bolts may be installed by holding the fastener head tightly against the housing with vise-grip pliers and
