Beechcraft

SERVICE INSTRUCTIONS

No. 0481-241
ATA Code 71-40

SUBJECT: POWER PLANT - ATTACH FITTINGS - MODIFICATION OF THROTTLE CONTROL INSTALLATION.

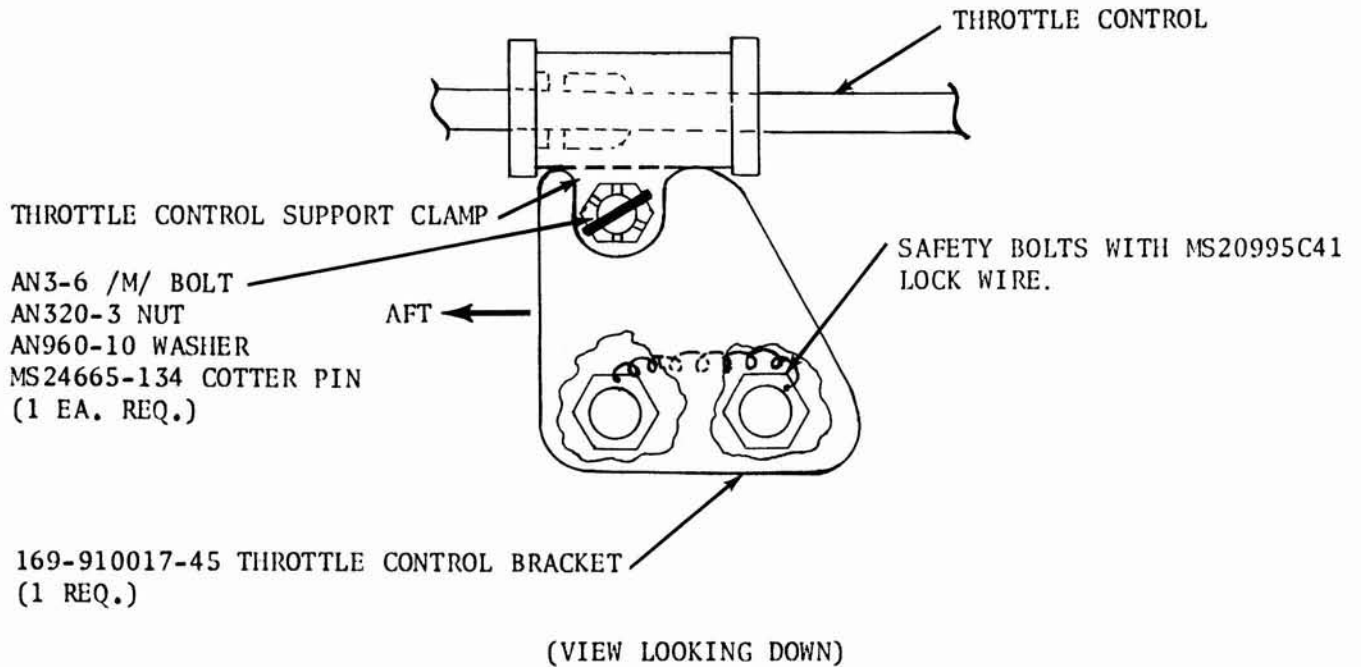
Figure 1. Installation of 169-910017-45 Throttle Control Bracket

REASON: To preclude the possibility of interference of the nose gear steering yoke with the throttle control installation.

5. Replace the 169-910017-23 bracket with a 169-910017-45 bracket. (Refer to Figure 1.) Place the edge of the -45 bracket between the ears of the throttle control support clamp and secure the clamp to the -45 bracket with an AN3-6 /M/ bolt (head of bolt down), an AN320-3 nut, an AN960-10 washer, and an MS24665-134 cotter pin. Secure the -45 bracket to the bottom of the crankcase with the existing attaching parts, and safety the two attaching bolts with MS20995C41 lock wire.

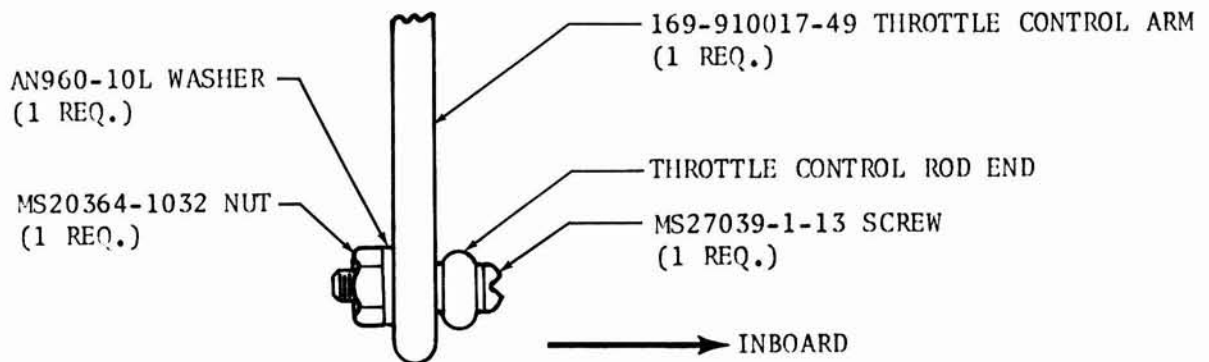
Figure 2. Installation of 169-910017-49 Throttle Control Arm

Install the throttle control rod end and the head of the MS27039-1-13 screw on the inboard side of the 169-910017-49 throttle control arm as shown in Figure 2 to prevent possible interference with the landing gear warning horn switch bracket.

- Attach the throttle control rod end to the 169-910017-49 throttle control arm with an MS27039-1-13 screw, an MS20364-1032 nut, and an AN960-10L washer. (See Figure 2.)
