No. 0560-210  
ATA Code 32-20

### Kit No. 23-8007-1 S

**SUBJECT:** LANDING GEAR (NOSE GEAR STEERING) – MODIFICATION OF NOSE GEAR CENTERING CABLE

**EFFECTIVITY:** BEECHCRAFT Model A24R, serials MC-2 through MC-95;  
Sierra A24R, serials MC-96 through MC-126 except MC-104.

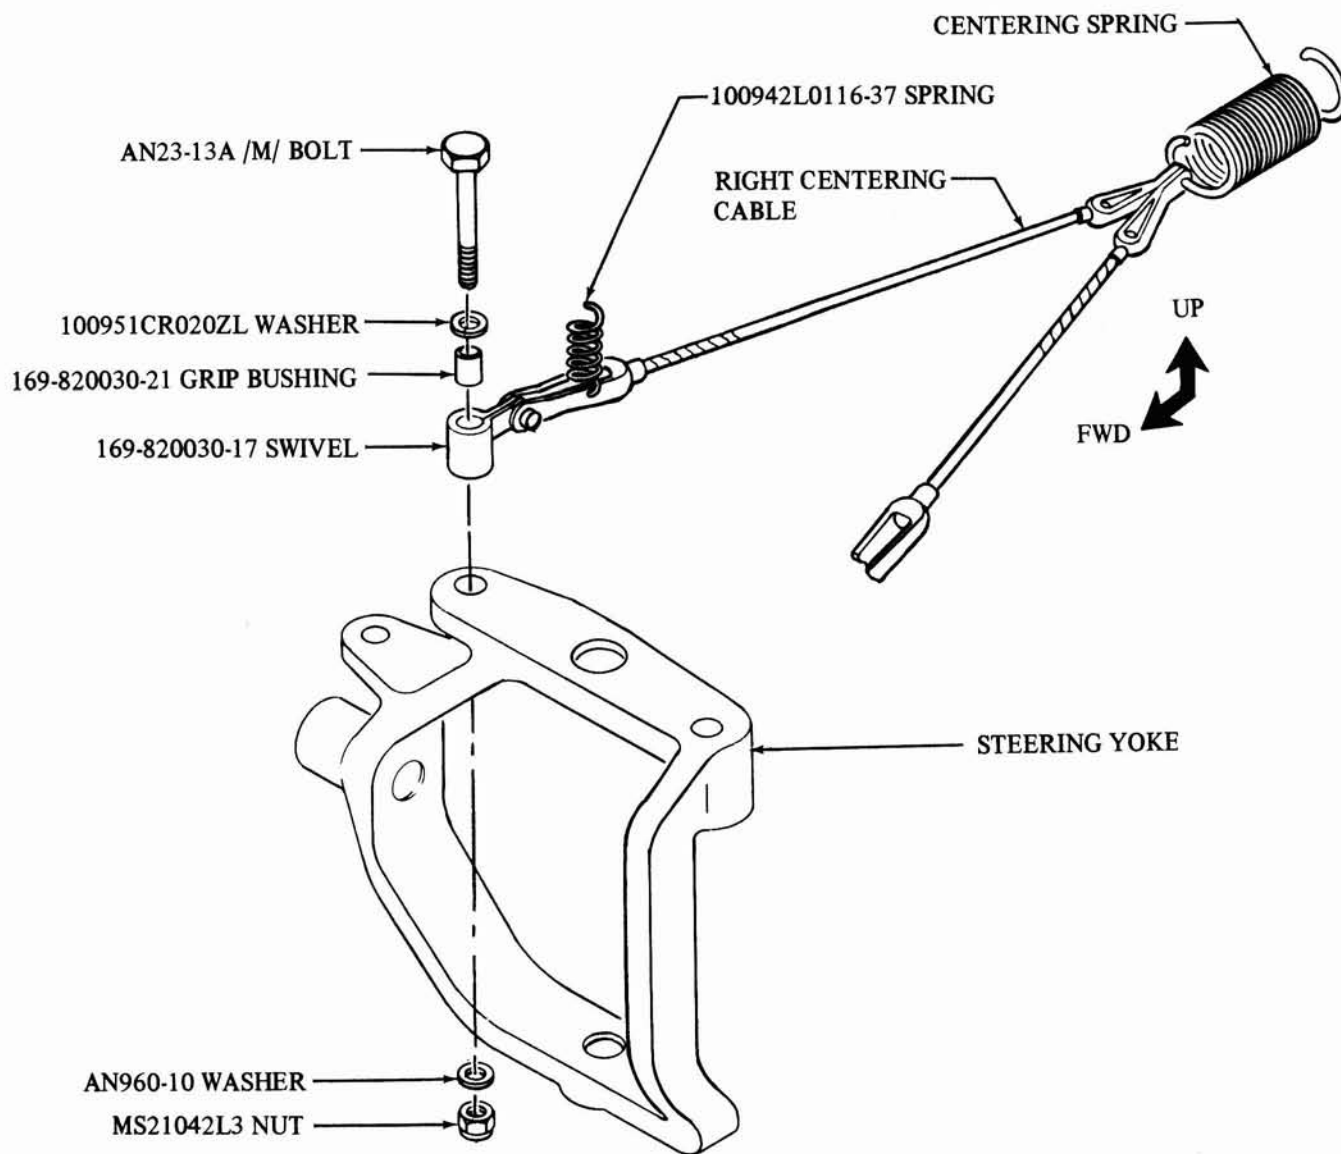
NOSE GEAR CENTERING CABLE INSTALLATION

**REASON:** To provide additional clearance between the right hand centering cable and the throttle arm.

**DESCRIPTION:** The original right hand centering cable, grip bushing, swivel, and bolt are removed and new ones are installed. A clamp is installed on the right forward intake tube and a spring is connected from the clamp to the centering cable fork.

Install the clamp on the intake tube at a distance of one inch outboard from the side of the oil pan.

9. Attach the 100942L0116-37 spring to the right hand centering cable at the hole in the forward fork.
10. With the new spring installed it will be necessary to grind a recess in the engine mount to provide clearance for the spring. Use a file or hand grinder to remove metal from the area indicated on the ENGINE MOUNT illustration.
11. Clean, prime and paint the area from which metal was removed.
12. Remove the aircraft from the jacks.
13. Reinstall the lower engine cowl.
