SERVICE INSTRUCTIONS

No. 0574-241
ATA Code 71-00

SUBJECT: POWERPLANT - MODIFICATION OF CARBURETOR AIRBOX VALVE

EFFECTIVITY: BEECHCRAFT Model 23, B23 and C23, serials M-1 through M-554 and M-1095 through M-1361, except M-3;
Sundowner C23, serials M-1362 through M-1420, M-1423, M-1425, M-1426, M-1430, M-1434, M-1438, M-1439, M-1442, M-1443, M-1447 and M-1453 through M-1473;
Model A23-19, 19A, M19A and B19, serials MB-1 through MB-520;
Sport B19, serials MB-521 through MB-585.

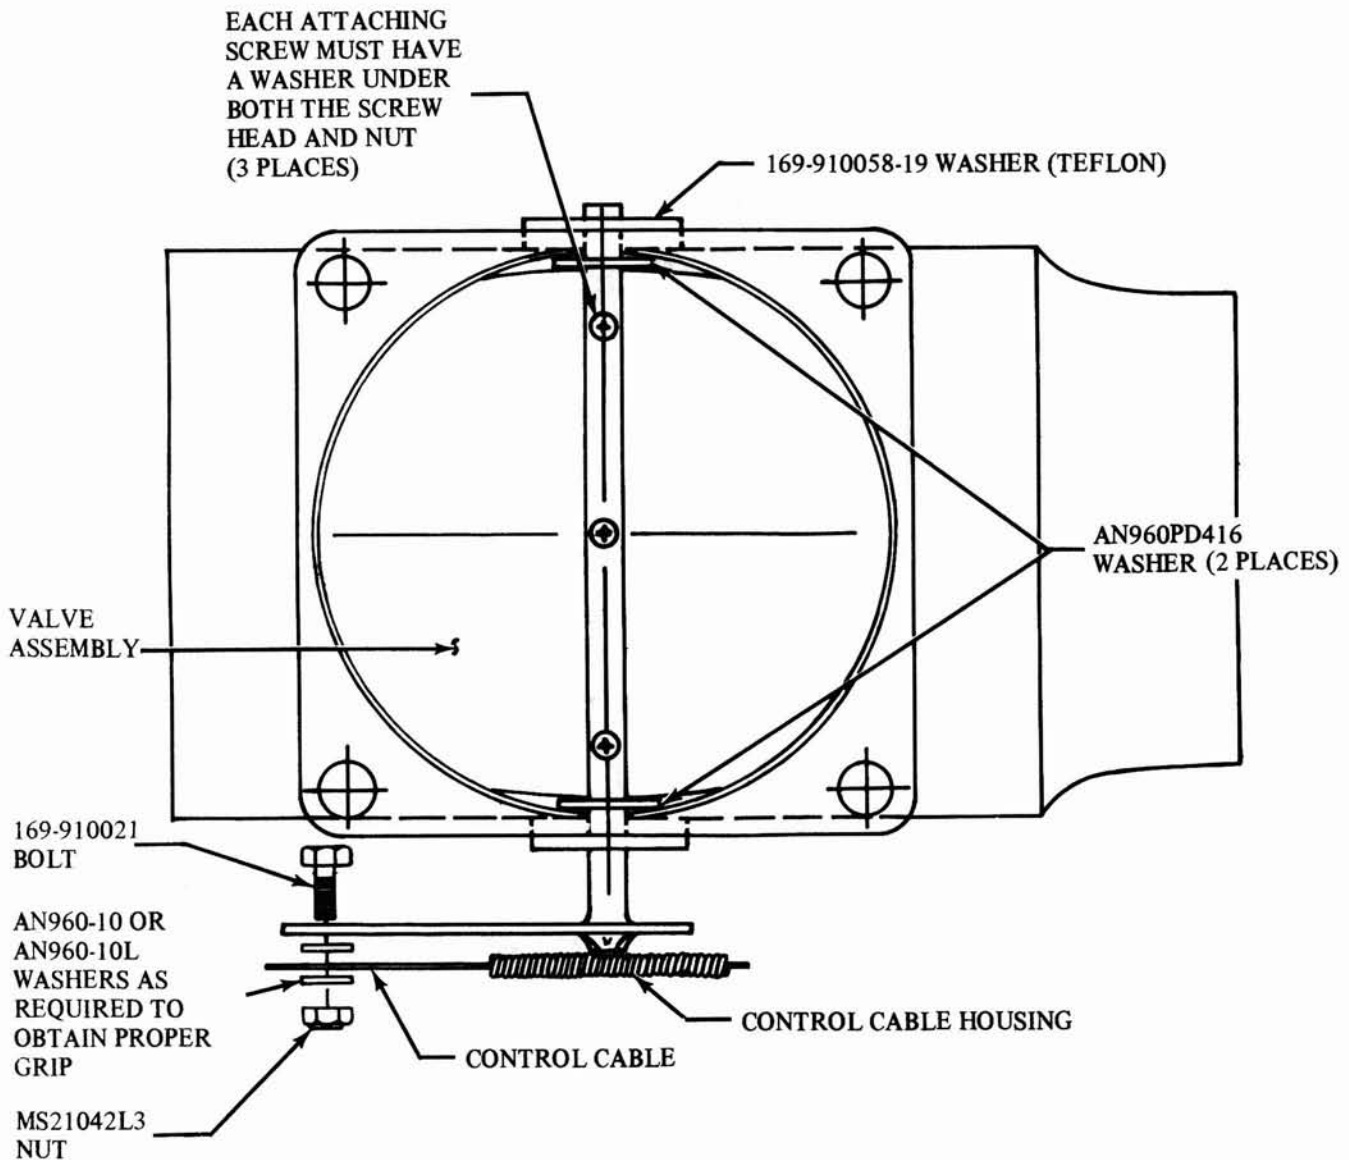
Figure 1. Looking Down on Carburetor Airbox

REASON: To prevent possible malfunction of the carburetor airbox valve. These Service Instructions No. 0574-241 cancel and supersede Service Instructions No. 0471-241 and Revisions thereof.

8. Install the new valve assembly and AN960PD416 washers as indicated in Figure 1.
9. Install the new screws, washers and nuts through the valve and shaft making certain to place a washer under both the screw head and the nut.
