SUBJECT: ENGINE CONTROLS - MODIFICATION OF CARBURETOR THROTTLE ARM ATTACHMENT

Service Instructions No. 0589-159, Rev. I

Service Instruction No. 1265A
(Supersedes Service Instruction No. 1265)
Engineering Aspects are
FAA (DEER) Approved

SUBJECT: Serrated Throttle Lever and Shaft
MODELS AFFECTED: Normally aspirated Avco Lycoming engines.
TIME OF COMPLIANCE: As required; during carburetor overhaul.

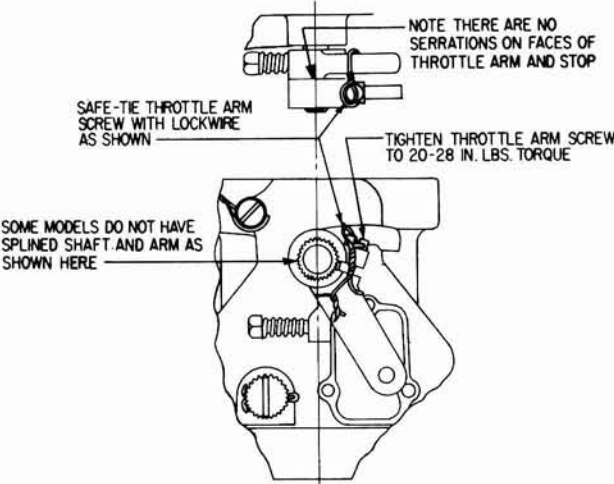
The superseded lever was tightened on the shaft by the clamping action of the attaching screw and secured

with lockwire. See fig. 1. The serrated feature of the new lever and shaft insures positive locking and eliminates the requirement for safety wire and torque requirements as specified in Service Bulletin No. 330A.

Figure 1. Previous Throttle Arm Configuration Showing Clamping Screw and Lockwire

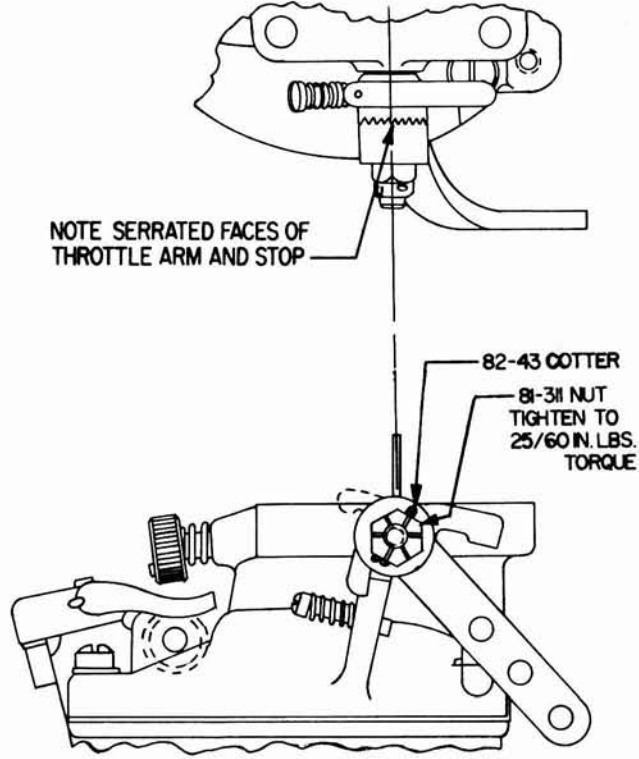
Figure 2. New Throttle Arm Configuration Showing Serrated Faces of Arm and Stop Levers

All Marvel-Schebler carburetors are now being furnished and serviced with serrated throttle levers and shaft. Refer to Marvel-Schebler Aircraft Carburetor Manual for overhaul and modification instruction. The new components in the following list replace the old smooth shaft and throttle lever assemblies. They are adjustable 360° in increments of 15°.
