SERVICE INSTRUCTIONS

No. 0627-159
ATA Code 76-10

SUBJECT: ENGINE CONTROLS - POWER CONTROL - MODIFICATION OF ENGINE QUADRANT CONTROLS FRICTION MECHANISM.

EFFECTIVITY: BEECHCRAFT Sundowner C23, serials M-1413, M-1414, M-1416 through M-1418, M-1420 through M-1422, M-1424 through M-1438, M-1440 through M-1445, and M-1453 through M-1476;
Sport B19, serials MB-558 through MB-598;
Sierra B24R, serials MC-151, MC-152, and MC-155.

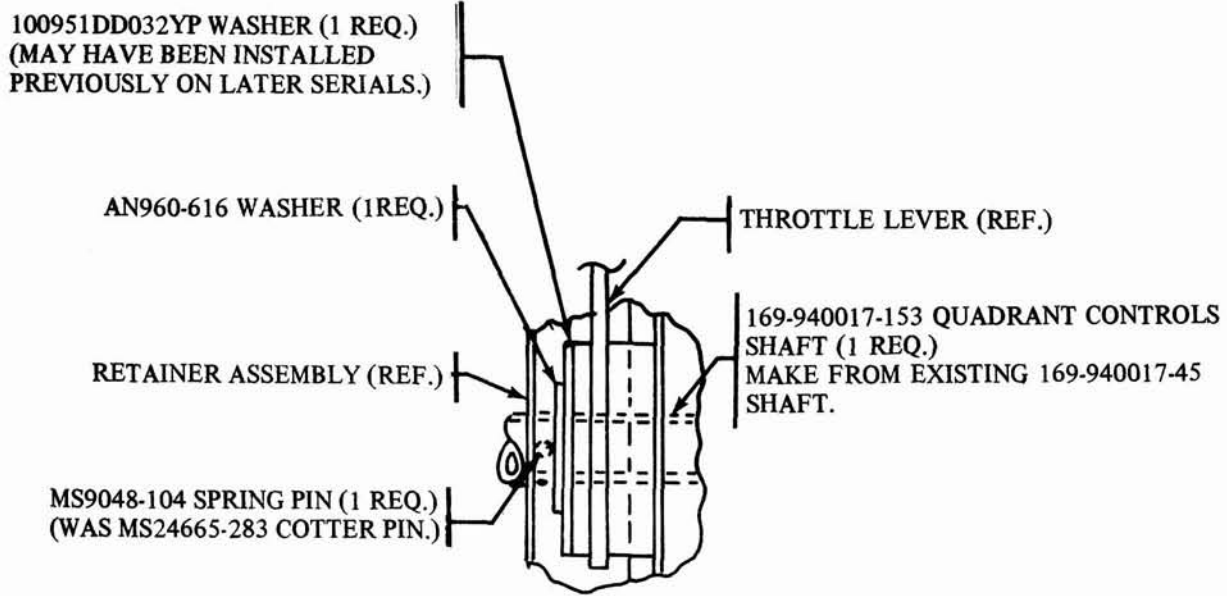
LOOKING FORWARD NEAR LH END OF ENGINE
QUADRANT CONTROLS INSTALLATION

friction lock mechanism, remove the 169-940017-43 nut from the right hand end of the 169-940017-45 quadrant controls shaft (Figure 1).

4. Remove the MS24665-283 cotter pin (Figure 1) located approximately 3/8 inch from the left hand end of the 169-940017-45 shaft. Remove the shaft from the friction lock mechanism by pulling out the shaft from the right hand side. Discard the MS24665-283 cotter pin.

a. If a 100951DD032YP washer is not now installed at the location shown in Figure 1, remove the existing washer at that location and replace it with a 100951DD032YP washer.

b. Install an AN960-616 washer at the location shown in Figure 1. Remove the existing washer at that location (if installed) and discard.
