CLASS I SERVICE INSTRUCTIONS

No. 0638-240, Rev. I
ATA Code 28-00

SUBJECT: POWER PLANT - INSPECTION OF PLUMBING FITTINGS AT THE FIREWALL

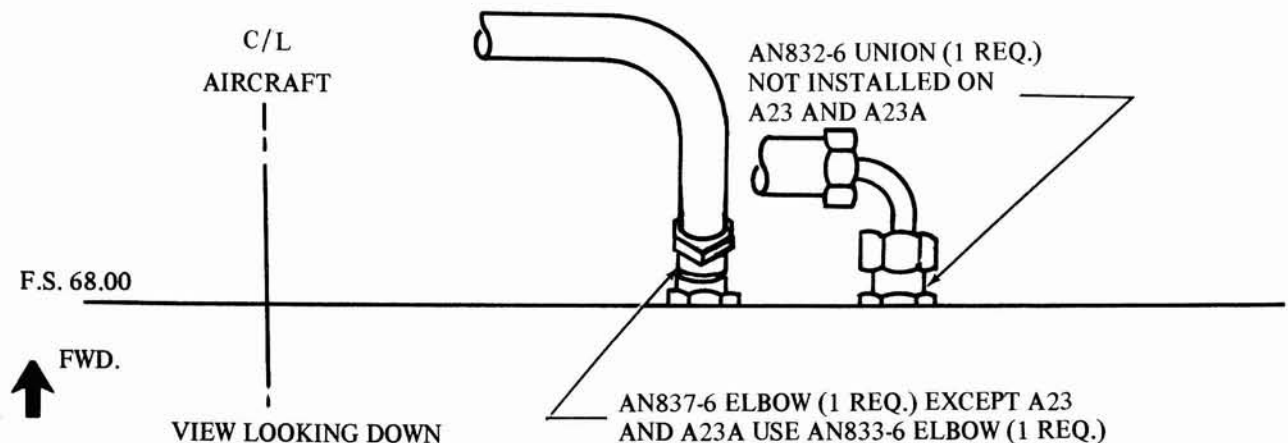
Inspection of plumbing fittings at the engine firewall covered in detail in PART I and PART II, must be performed to determine if replacement is necessary. If a fitting is blue in color, it is aluminum and must be replaced.

1. Remove the engine cowling if not already removed and inspect the firewall fuel line union and elbow shown in the illustration and if necessary, replace them with an AN832-6 union and AN837-6 elbow. An AN960-916 washer must be installed between the union and the firewall.
