No. 0679-395, Rev. II
ATA Code 28-40, 79-30

SUBJECT: INSTRUMENT - SUBPANEL - INSPECTION OF FUEL QUANTITY AND OIL TEMPERATURE INDICATION SYSTEMS

EFFECTIVITY: BEECHCRAFT B19 Sport 150, serials MB-655 through MB-786;
C23 Sundowner 180, serials M-1517 through M-1786;
B24R Sierra 200 serials MC-199 and MC-209 through MC-405.

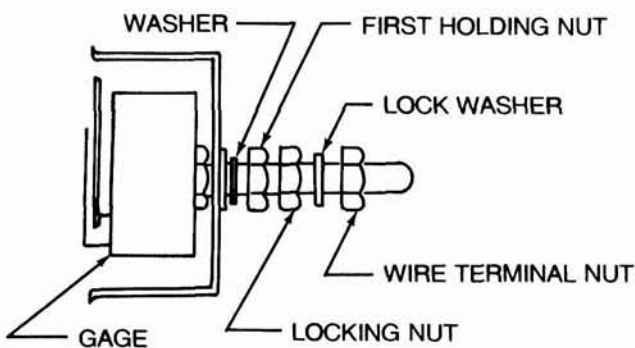
SIDE VIEW

DESCRIPTION: The terminal posts on the fuel quantity gages and oil temperature gage are to be retorqued to ensure proper installation. The oil temperature gage indication is to be checked with a known resistance in the system.

1. Ensure that all electrical power is turned off.
2. Disconnect the electrical wires and loosen all hardware on the two terminals on the back of each fuel quantity and oil temperature gage. (See illustration.)

3. Using a torque wrench, retorque the first holding nut on each terminal to 20/22 inch-pounds. (See illustration.)
4. Hold the first holding nut with a 3/8-inch open end wrench (not to exceed .09-inch thickness) and torque the locking nut on each terminal to 22 inch-pounds. (See illustration.)
5. Reinstall the electrical wires which were removed in step two except to the "Send" terminal of the oil temperature gage. (Do not exceed 20 inch pounds torque on the terminal.)
6. Hold the first holding nut with the 3/8-inch wrench when tightening the nut down on the wire terminal.
