# CLASS III SERVICE INSTRUCTIONS

No. 0682-202  
ATA Code 32-00

**SUBJECT:** LANDING GEAR - MAIN GEAR ASSEMBLY - INCREASED TIRE CLEARANCE ON MAIN LANDING GEAR STRUTS

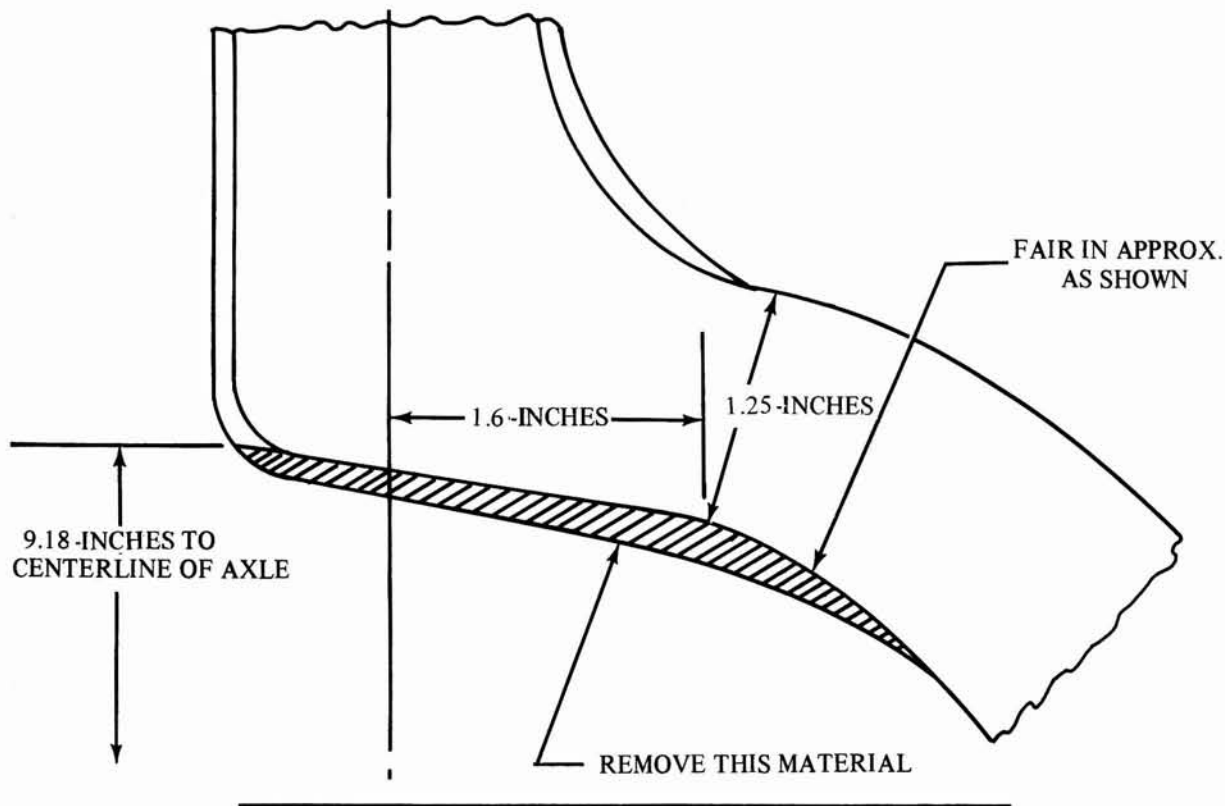
**REASON:** Installation of larger diameter main landing gear tires in the field on earlier aircraft serials, which were not previously equipped with the larger tires, requires rework of the struts to provide clearance for the tires.

1. Place the aircraft on jacks.
2. Remove the main gear wheels and tires from the landing gear assemblies and remove material from the main gear struts as shown in the illustration.

3. Smooth the reworked area with a fine file or sandpaper to remove all tool marks.
4. Treat the exposed metal surfaces with a chemical film treatment such as Iridite, Alodine or Chromic Acid to protect the area from corrosion.

7. Reinstall the tires and wheels on the main gear struts and check for clearance. There should be a minimum of .19-inch clearance between a new tire and the strut at the closest point.
