SERVICE INSTRUCTIONS

No. 0698-359 Rev. I
ATA Code 24-30

SUBJECT: ELECTRICAL - ALTERNATOR - MODIFICATION OF ALTERNATOR ATTACHMENT AND SECURITY OF WIRING

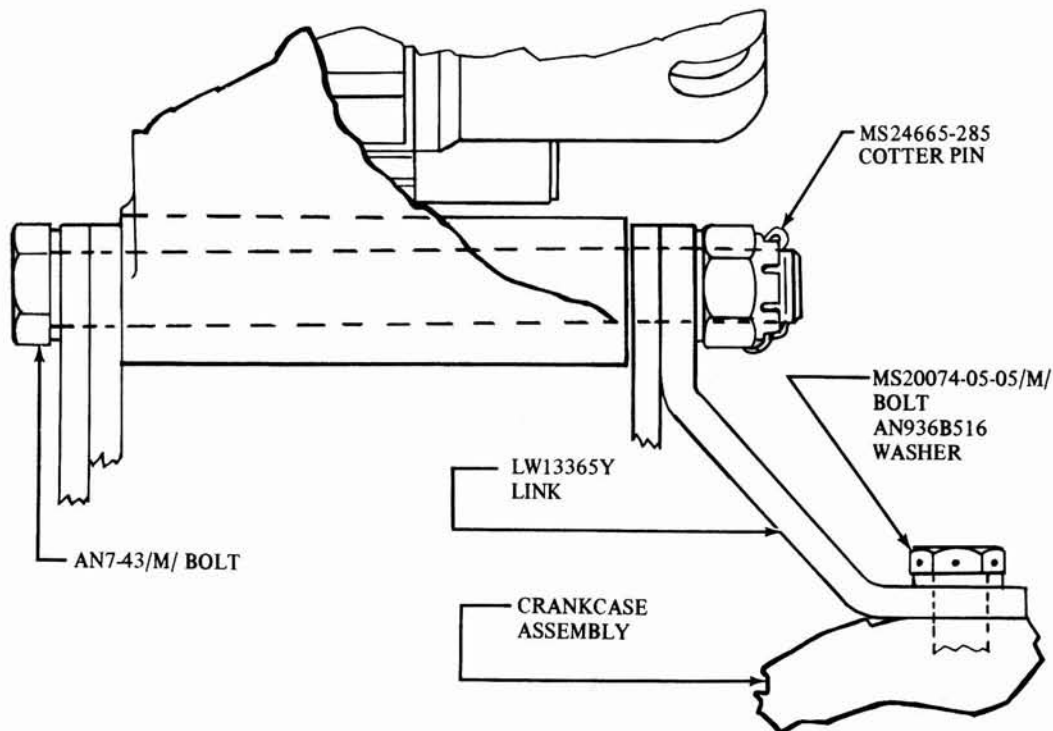
Figure 1. Installation of Link.

REASON: Provide an additional brace for the alternator and an improved attachment of the alternator wire.

1. Remove the lower engine cowling.
2. Loosen the alternator drive belt and remove and discard the alternator mounting bracket bolt that attaches the alternator to the mounting bracket. Retain the nut and washers.
3. Attach the P/N LW13365Y link to the crankcase assembly using the MS20074-05-05/M/ bolt and AN936B516 washer as shown in figure 1.
4. Install the new AN7-43/M/ bolt with the existing nut and washer as shown in figure 1.
5. Before tightening the AN7-43/M/ bolt, check the drive belt tension using either of the following methods:

7. Install the MS24665-285 cotter pin through the nut and bolt as shown in figure 1.
