SERVICE INSTRUCTIONS

No. 0731-114
ATA Code 52-10

SUBJECT: DOORS - REPLACEMENT OF DOOR HANDLES AND CABIN DOOR LATCH BOLTS

**BEECHCRAFT B19 Sport 150, serials MB-617 through MB-696;
C23 Sundowner 180, serials M-1485 through M-1563;
B24R Sierra 200, serials MC-181 through MC-268.**

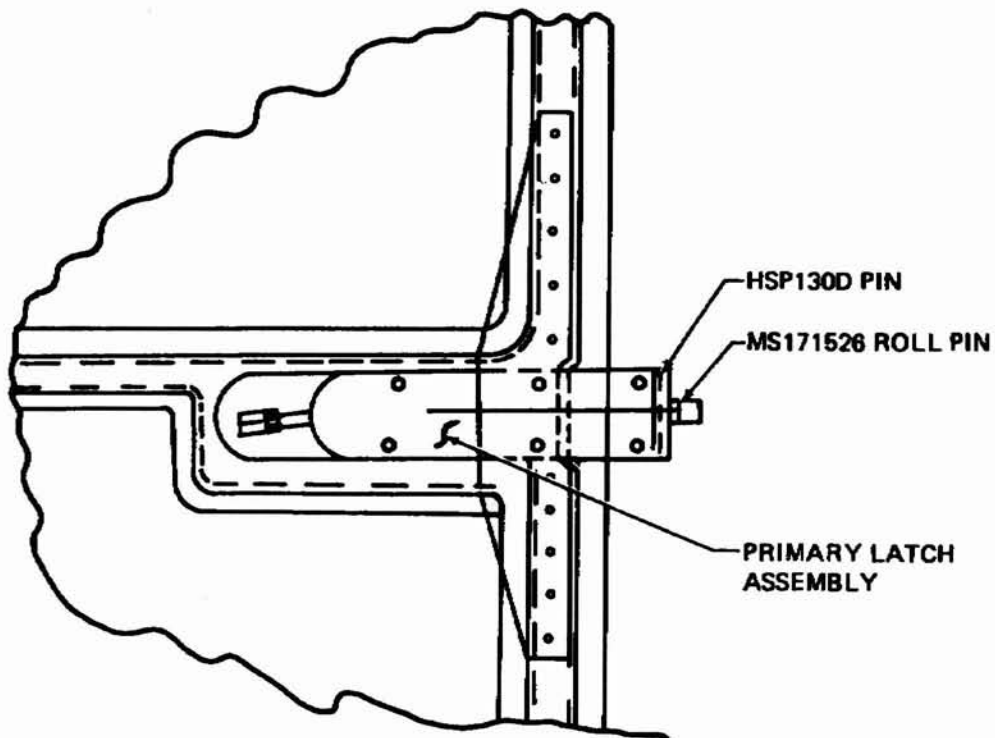
To provide cabin and baggage door handles with more positive locking ability and cabin doors with more durable latch bolts.

- PART I ONLY 3. Remove the eight attaching screws and slide the primary latch assembly aft as shown in illustration. Remove the swelled HSP130D pin by driving with small punch through housing of latch.

- PART I ONLY 4. Pull shaft and latch bolt aft to gain access to rivet pin. Split old plastic latch bolt and remove the rivet pin. Install new P/N 111501-1 steel latch bolt over shaft and install P/N MS171526 roll pin through latch bolt and shaft.

- PART I ONLY 5. Slide shaft and latch bolt back in housing and install new P/N HSP130D pin with head of pin on top side. Swage lower end of pin by using a center punch. Slide latch assembly back in door to original position and install the eight attaching screws.

- PARTS I AND II 7. Remove the inside window moulding and with the door open and the upper latch in the closed position check for proper adjustment of the upper latch bolt. The ears on the bolt should engage the fiberglass frame at the edge of the cut-out for the latch. It may be necessary to restrict excessive movement of the latch bolt by installing a spacer between the top of the turnbuckle and the bottom of the plastic guide just above the turnbuckle.

The spacer may be made from a stack of AN960-10 washers or equivalent. Reinstall the window moulding.
