SERVICE INSTRUCTIONS

No. 0751-157
ATA Code 51-00

SUBJECT: FLIGHT CONTROLS - PEDESTAL STRUCTURE - INSPECTION OF FLAP AND STABILATOR TAB CONTROL PEDESTAL

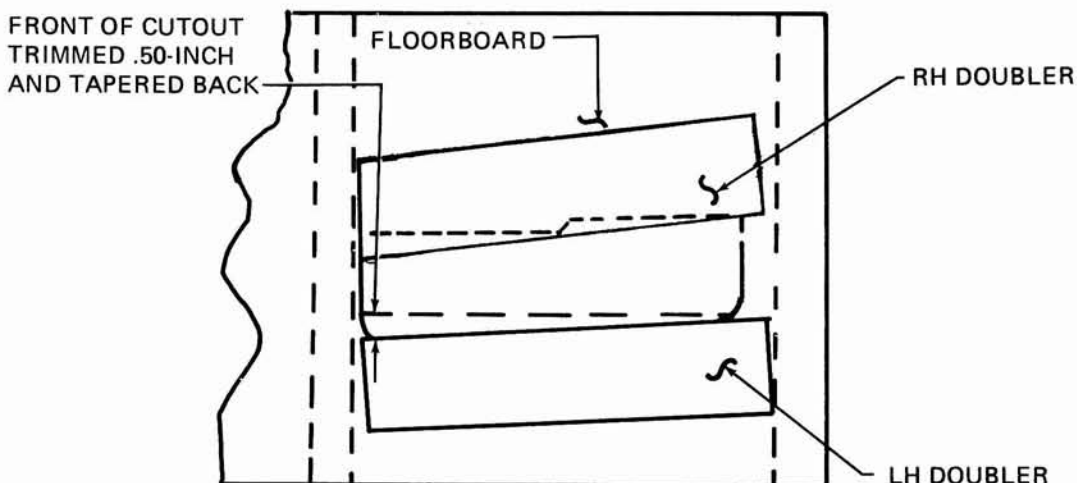
REASON: To provide additional spacing, if required, between the flap handle and the fuel selector valve handle to preclude the possibility of inadvertent actuation of the fuel selector when grasping the flap handle.

Measure the distance between the center line of the fuel selector valve handle shaft and the center line of the flap handle to determine if this modification is required. If the distance is less than 2.9 inches, proceed with the following steps.

3. Trim the cutout in the floor .50-inch as shown in the illustration and fabricate two doublers 2.0 x 9.0-inches using .040-inch 2024-T3 aluminum alclad flat sheet.

4. Install the aft left hand screw attaching the pedestal to the floor but do not tighten.
5. Move the front of the pedestal .50-inch to the left of its original position and install one doubler on the left hand side of the cutout between the pedestal and the floorboard, flush with the trimmed edge of the cutout (see illustration). Using the existing holes in the pedestal as guides, drill holes through the doubler and floorboard with a No. 30 (.1285-inch) bit and trim the doubler to fit as required. Attach the doubler and pedestal to the floor with temporary fasteners.

6. Install the right hand doubler as shown in the illustration. Drill holes through the doubler and pedestal using the holes in the pedestal as guides with a No. 30 (.1285-inch) bit and attach the doubler and pedestal to the floor with temporary fasteners.

7. With a No. 30 (.1285-inch) bit, drill 6 holes, equally spaced, along the outboard edges of each doubler, with an edge distance of $.25 \pm .03$ -inch.
8. Determine how much the aft right hand hole will have to be elongated to accept the screw that was removed in step 2, remove the fasteners and elongate the hole as required.
