CLASS I SERVICE INSTRUCTIONS

No. 0824-035, Rev. II
ATA Code 57-10
Recurring Inspection

SUBJECT: WINGS - INSPECTION OF THE MAIN SPAR

EFFECTIVITY: BEECHCRAFT 19 series;
23 series;
24 and 24R series;
that are five years old or older, except those affected by the Note in the COMPLIANCE Section.

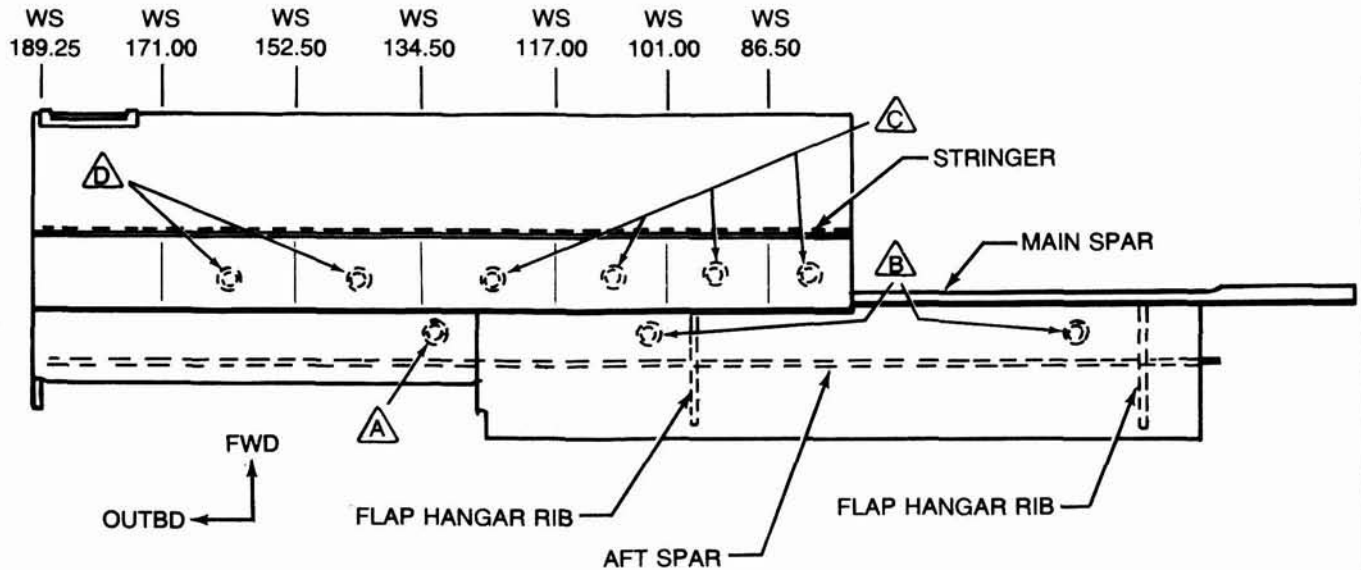
Required for corrosion inspection.
-

Required for corrosion inspection on fixed landing gear airplanes.
-

Permissible access for treatment of corrosion forward of main spar on fixed landing gear airplanes only.
-

Permissible access for treatment of corrosion forward of main spar.

1. Remove the LH and RH wing tips.
2. On the LH and RH wing, cut a 5.0-inch diameter hole at W.S. 133, centered between the main spar and aft spar as shown in the illustration at position "A" located on the bottom of the wing.

3. On the LH and RH wing, cut a 5.0-inch diameter hole at W.S. 104 and W.S. 44, centered between the main spar and the aft spar as shown in the illustration at position "B" located on the bottom of the wing.
4. Visually inspect the aft side of the wing main spars through the access openings and the forward side of the wing main spars through the spar lightning holes from the fuselage to the wing tip in accordance with procedures in FAA Advisory Circular AC43-4, or subsequent revision for corrosion.
5. If no corrosion is found, proceed to step 7 and 8.

- d. For cleaning and treatment of corrosion forward of the wing main spar, it is permissible to cut a 5.0-inch diameter hole between the main spar and the first stringer forward of the main spar, centered between ribs as shown in the illustration at position "C" and "D" located on the bottom of the wing.
