# CLASS I SERVICE INSTRUCTIONS

No. 0835-111  
ATA Code 54-10

**SUBJECT:** NACELLES - MODIFICATION OF THE ENGINE FIREWALL

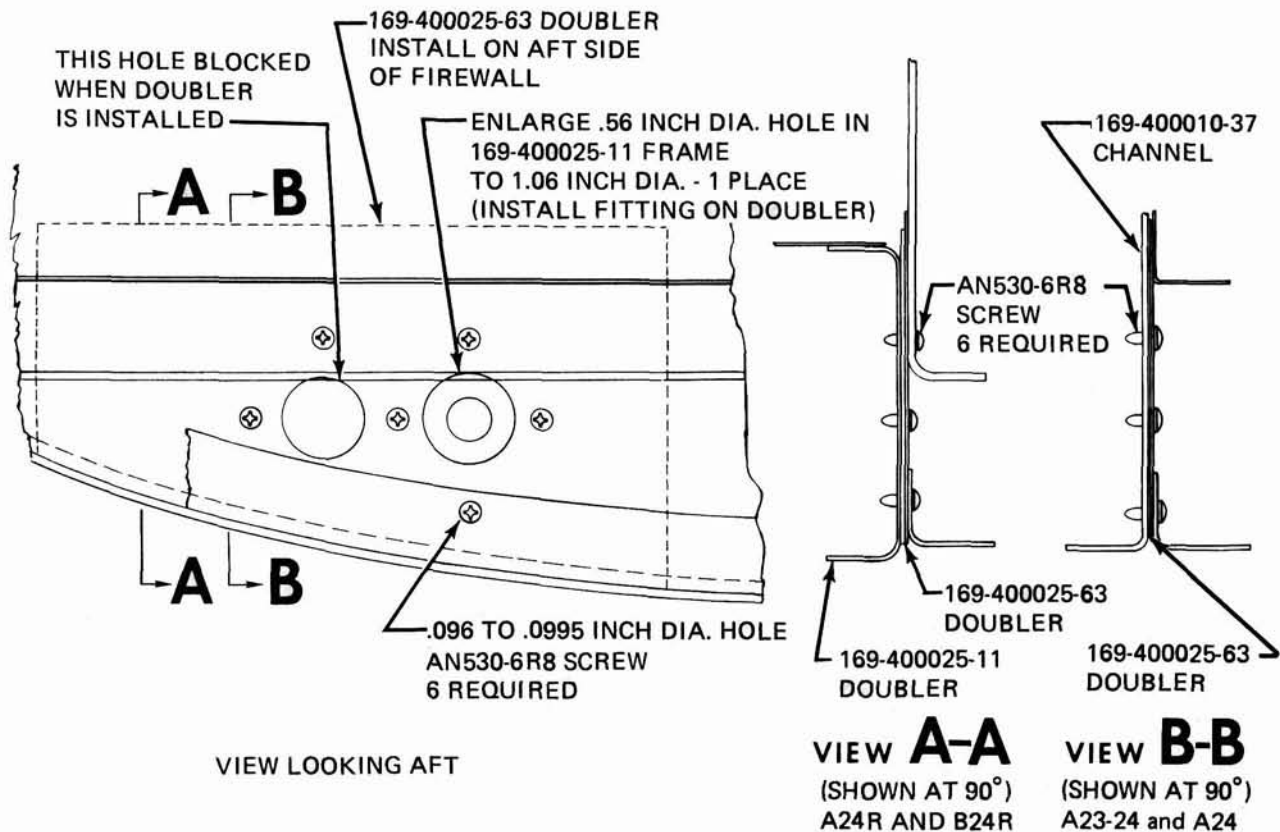
Figure 1.

**DESCRIPTION:** A doubler is added to the lower right hand side of the engine firewall.

DOUBLER INSTALLATION FOR A23-24, A24, A24R AND B24R

1. For all model A23-24, A24, A24R and B24R airplanes listed under EFFECTIVITY, install the P/N 169-400025-63 doubler between the fuselage frame and the aft side of the engine firewall as shown in figure 1.
2. For all model A23-19, 19A, M19A, B19, B23 and C23 airplanes listed under EFFECTIVITY, install P/N 169-400010-165 doubler on the forward side of the engine firewall as shown in figure 2.
