SERVICE INSTRUCTIONS

No. 0861-281
ATA Code 28-20

SUBJECT: FUEL - REPLACEMENT OF THE FUEL BOOST PUMP

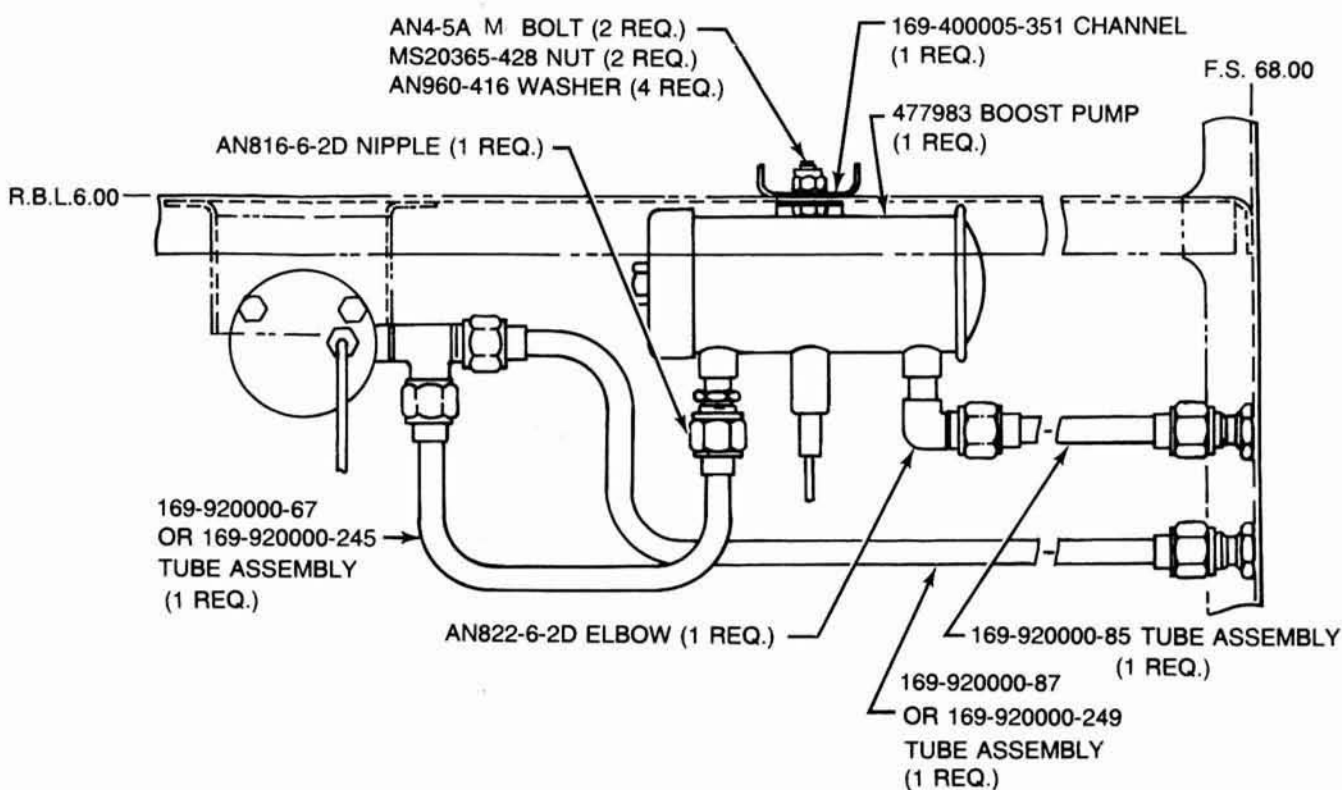
REASON: To provide a replacement fuel boost pump for the existing fuel boost pump that is no longer available.

2. Remove the co-pilot's seat.
3. Remove the co-pilot's rudder pedal cover assembly.
4. Remove the boost pump access door.
5. Remove the fuel boost pump.
6. Remove the tube assembly, boost pump to firewall.
7. Remove the tube assembly, firewall to strainer tee.
8. Remove the tube assembly, strainer tee to boost pump.
9. Install AN816-6-2D nipple to the "In" port of the new boost pump.
10. Install AN822-6-2D elbow to the "Out" port of the new boost pump.
11. Install the P/N 477983 boost pump and 169-400005-351 channel with AN4-5A/M/ bolt, AN960-416 washer, and MS20365-428 nut through the existing holes in the keel at fuselage station 78.40 (10.4 inches aft of the firewall).

Trim the diagonal channel between the inboard and outboard keel as necessary to provide clearance between the channel and the new boost pump.

12. Complete the installation of the fuel line tube assemblies.

It may be necessary to make minor adjustments to the tube assemblies and/or shim the firewall fittings in order to ensure proper alignment of the installation. Use care when hand-bending the tube assemblies so as not to crimp or damage them.
