19, 23, 24

No. 0940, Rev. I
ATA Code 27-50

SUBJECT: FLIGHT CONTROLS - REPLACEMENT OF THE FLAP CONTROL WELD ASSEMBLY

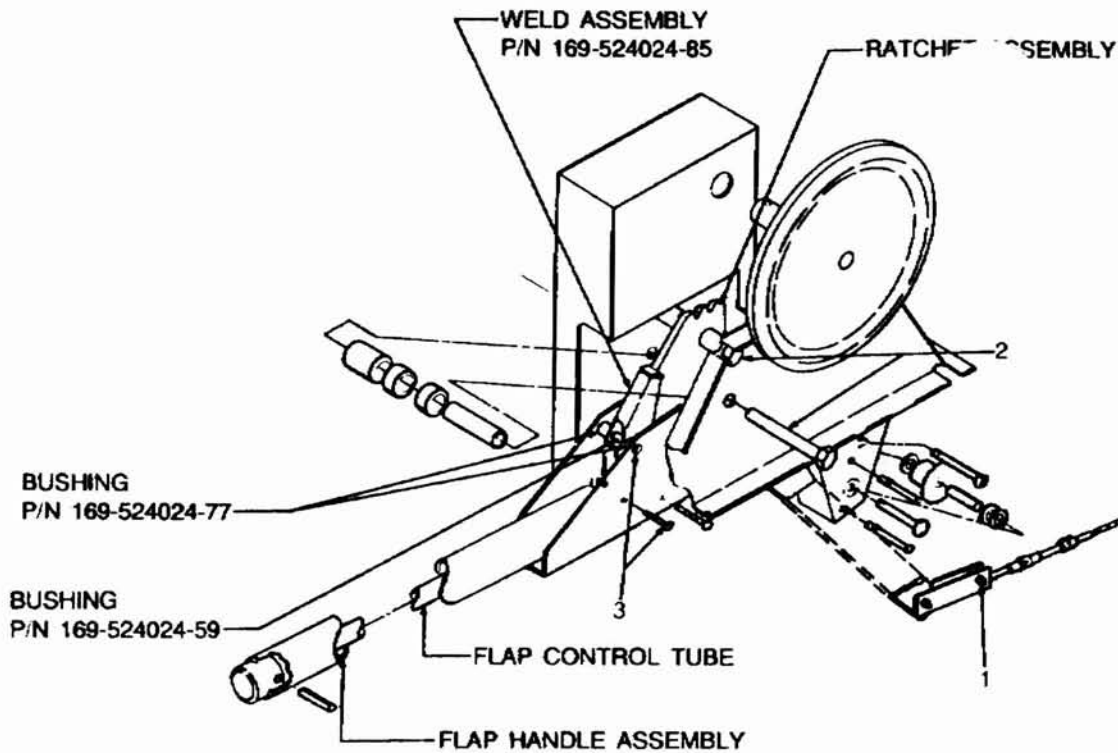
To replace the existing flap control weld assembly and bushings with an improved flap control weld assembly and improved bushings.

To replace the existing flap control weld assembly with an improved flap control weld assembly.

1. Remove the pilot chair and the copilot chair.
2. Remove the floorboard and access plate immediately aft of the trim console.
3. To facilitate reassembly and rerigging, temporarily secure the flap control cable to the airplane structure using blocks and clamp. Disconnect the flap cable eye from the flap control link by removing the one attaching bolt. Refer to index number (1) on the illustration. Retain the attaching hardware.

4. Remove the two bolts that secure the flap handle assembly, flap control weld assembly, and ratchet assembly to the trim console. Reference index (2) on the illustration. Retain all attaching hardware.

5. Remove the flap handle assembly, flap control weld assembly, and ratchet assembly from the trim console.
6. Remove the one bolt and one clevis pin that secure the flap control weld assembly to the flap handle assembly. Remove the flap control weld assembly. Reference index (3) on the illustration. Retain the attaching hardware.

7. On airplanes listed under Part I of the EFFECTIVITY section, replace the two existing P/N 169-524024-61 side bushings with the new P/N 169-524024-77 side bushings and install the new P/N 169-524024-85 weld assembly, using the existing bolt, nut, washer and P/N 169-524024-59 through bushing. On airplanes listed under Part II of the EFFECTIVITY section, use the existing bolt, nut, washer and bushings.
