No. 0967
ATA Code 32-40

SUBJECT: LANDING GEAR - INSPECTION FOR VENT HOLE IN BRAKE FLUID RESERVOIR

Service Instructions No. 0967

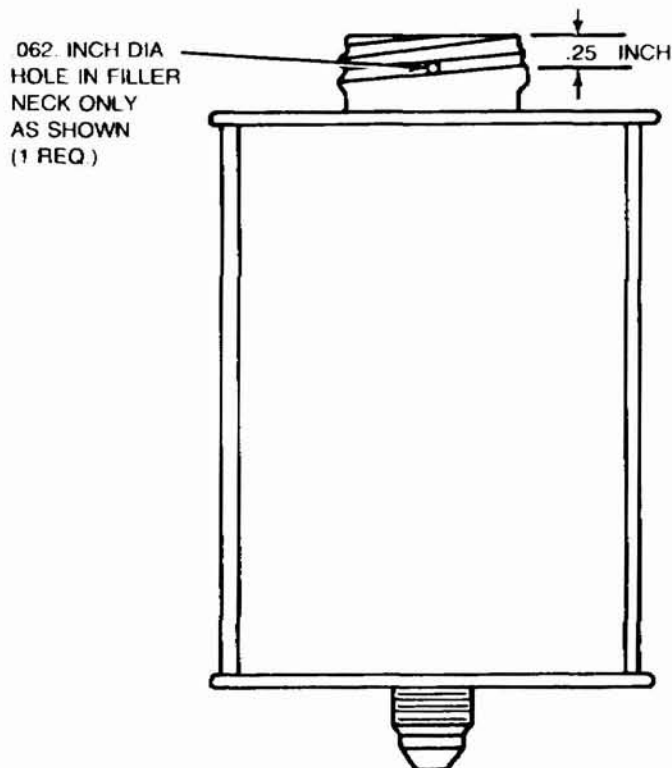
REASON: The vent hole in the brake fluid reservoir may have been inadvertently omitted on some airplanes.

1. Remove the brake fluid reservoir cap and inspect the reservoir filler neck for a vent hole as shown in the illustration. The brake fluid reservoir is located as follows:

3. If no vent hole is found, the reservoir should be removed and the vent hole drilled

as shown in the illustration.

If the hole is to be drilled, the reservoir must be thoroughly cleaned after drilling to remove all drill burrs, etc.
