No. 0994
ATA Code 27-30

SUBJECT: FLIGHT CONTROLS - INSPECTION OF THE STABILATOR TRIM TAB ACTUATOR ROD

EFFECTIVITY: BEECHCRAFT B19 Sport 150, serials MB-558 through MB-886;
C23 Sundowner 180, serials M-1413, M-1414, M-1416 through M-1418, M-1420 through M-1422, M-1424 through M-1438, M-1440 through M-1446, M-1448 through M-2009, M-2011 through M-2015 and M-2017 through M-2020;
B24R and C24R Sierra 200, serials MC-151 through MC-559, MC-561 through MC-563, MC-565 through MC-568 and MC-571.

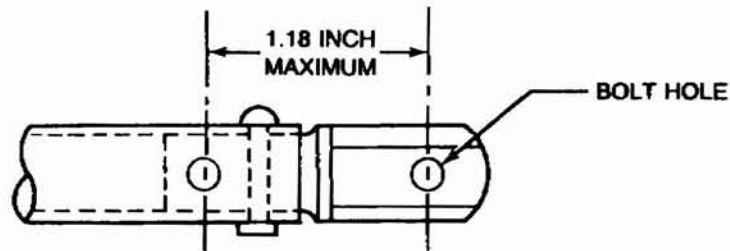
Figure 1.

1. On both ends of the rod, measure the distance from the center of the bolt hole through the clevis to the center of the second rivet through the rod and clevis (see figure 1.)

2. If the measurement taken in step 1 exceeds 1.18 inches on either end of the rod it will be necessary to rework the rod, continue with step 3. If the measurement is 1.18 inches or less on both ends no rework is necessary, omit steps 3 through 9.
3. Tag the actuator rod to ensure that it will be reinstalled in the same position after rework.
4. Remove the cotter pins, nuts, washers and bolts from both ends of the actuator rod and remove the rod through the slot in the aft end of the tail cone.
