No.1034
ATA Code 34-10

SUBJECT: NAVIGATION/PITOT AND STATIC - IMPROVED SEALING OF THE EMERGENCY STATIC AIR SOURCE VALVE

EFFECTIVITY: BEECHCRAFT Duchess 76, serials ME-1 through ME-63.

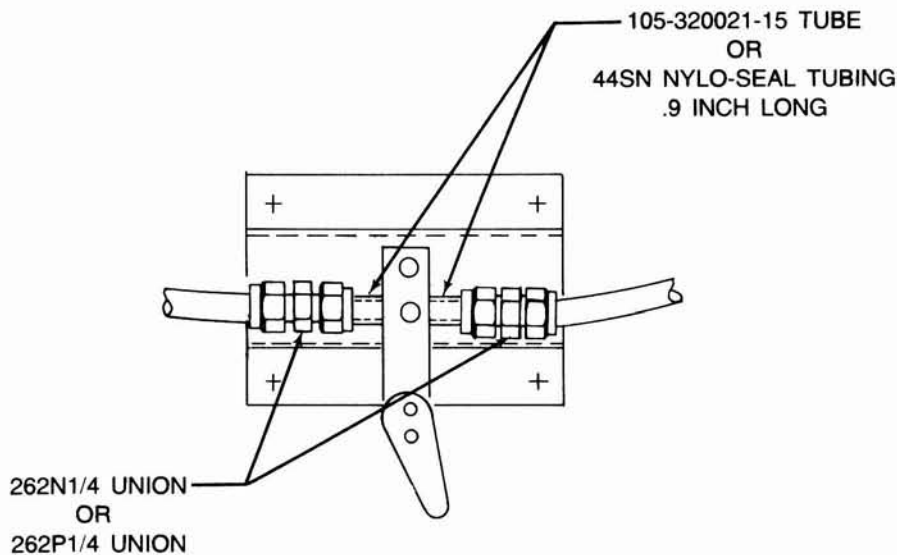
REASON: To improve the seal between the emergency static air source valve and the static lines by installing a union on each side of the valve.

1. Remove the upholstery panel forward of the left cabin door to gain access to the emergency static air source valve.
2. Disconnect the static air lines from both ends of the emergency static air source valve.
3. Trim .9 inch off of the end of both static air lines.
4. Attach a P/N 105-320021-15 tube or a .9 inch long piece of P/N 44SN Nylo-Seal tubing to both sides of the emergency static air source valve as shown in the illustration.

5. Connect the static air lines to the tubes on the emergency static air source valve with two P/N 262N1/4 or two P/N 262P1/4 unions as shown in the illustration.
6. The static system should be checked for leaks as specified in Federal Aviation Regulations 91.170 and Appendix E of Part 43.
7. Reinstall the upholstery panel.
