SERVICE INSTRUCTIONS

No. 1057
ATA Code 27-20

SUBJECT: FLIGHT CONTROLS - REPLACEMENT OF THE ELEVATOR AND RUDDER TAB PUSH RODS

EFFECTIVITY: BEECHCRAFT Duchess 76, serials ME-1 through ME-6, ME-8 through ME-62 and ME-66.

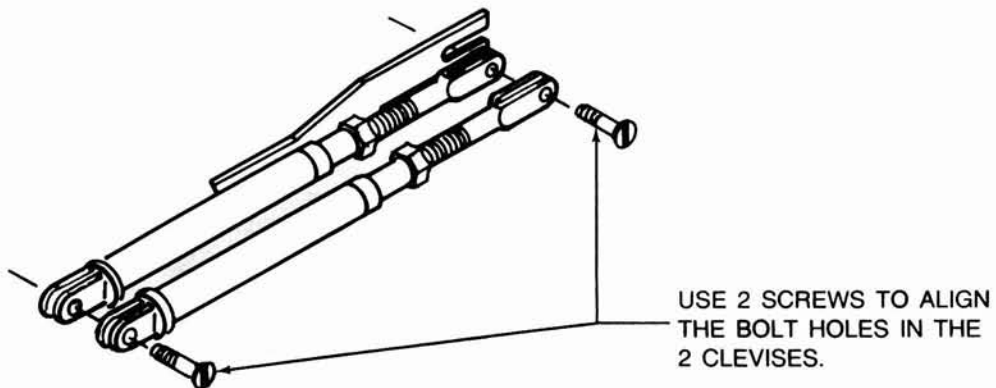
Figure 1.

2 SCREWS ALIGNED IN THE BOLT HOLES IN THE 2 CLEVISES.

SCREWS ARE NOT LINED UP EVENLY. MUST BE IN LINE.

NOTE: ON SOME INSTALLATIONS IT MAY BE NECESSARY TO DRILL A NEW .060 DIA. INSPECTION HOLE IN THE AFT END OF THE TRIM TAB PUSH ROD; .375 FORWARD OF AFT EDGE OF TUBE AND 90° TO EXISTING INSPECTION HOLE.

The clevis slot at the actuator (fwd.) end of the rod must be in the same plane as the tab horn clevis slot. (See figure 1.)

5. Adjust the new P/N 105-520048-1 elevator trim tab push rods to the measured length in step 4. (See figure 1.) Be certain to maintain the left and right identification of the rods when adjusting the new rods for correct length.
