# CLASS I SERVICE INSTRUCTIONS

No. 1065  
ATA Code 77-00

**SUBJECT:** ENGINE INDICATING - INSPECT THE ENGINE INSTRUMENT CLUSTER ASSEMBLY

**EFFECTIVITY:** BEECHCRAFT Duchess 76, serials ME-1 through ME-6 and ME-8 through ME-152.

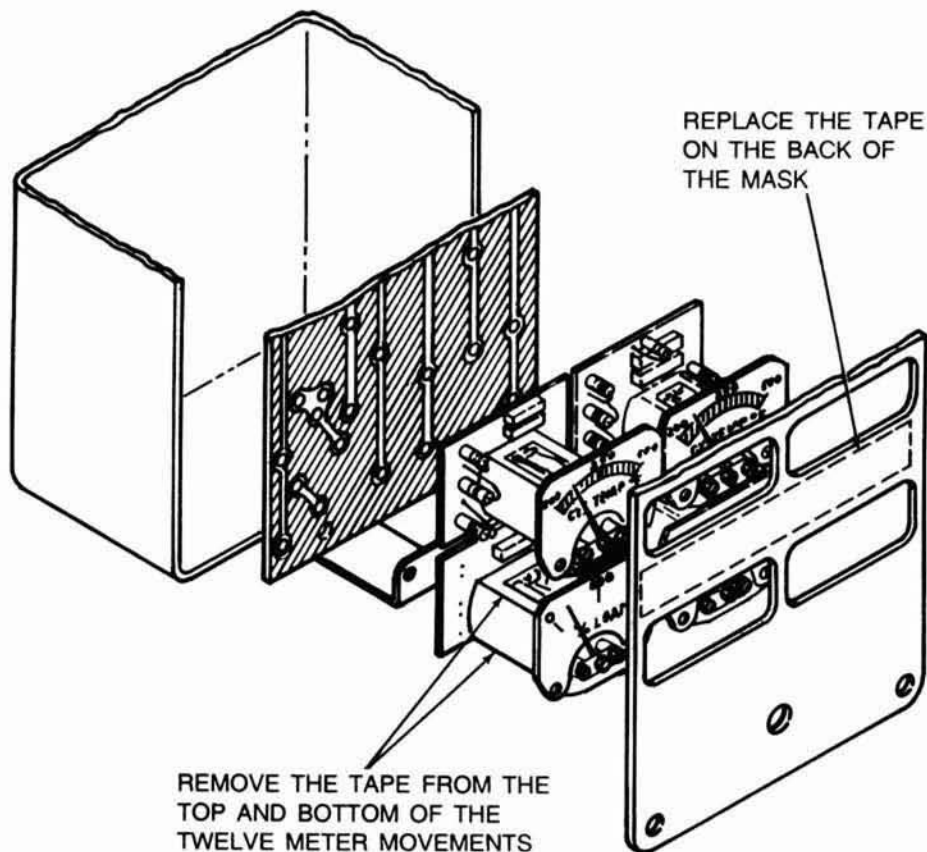
**REASON:** To inspect the engine instrument cluster assembly for date of manufacture, and if necessary, remove tape which may interfere with the operation of the engine instruments.

7. Using a small pair of tweezers, remove the yellow cellophane tape attached to the top and bottom of the twelve meter movements in the engine instrument cluster (see illustration). If it is necessary to remove an individual instrument to gain access to the meter movement, refer to the Duchess 76 Maintenance Manual, Chapter 77-00 to remove the instrument.

8. Remove the four screws attaching the engine instrument cluster mask to the supports and tilt the mask away from the engine instrument cluster to gain access to the back of the mask. Care should be taken not to damage the lights or wires which are attached to the mask.
9. Remove any yellow cellophane tape from the back of the mask and replace it with Scotch Brand Magic Transparent Tape No. 810 (obtain locally) (see illustration).
