# SERVICE INSTRUCTIONS

No. 1116  
ATA Code 55-40

**SUBJECT:** STABILIZERS - INSTALLATION OF DRAIN HOLES IN THE RUDDER AND RUDDER TRIM TAB

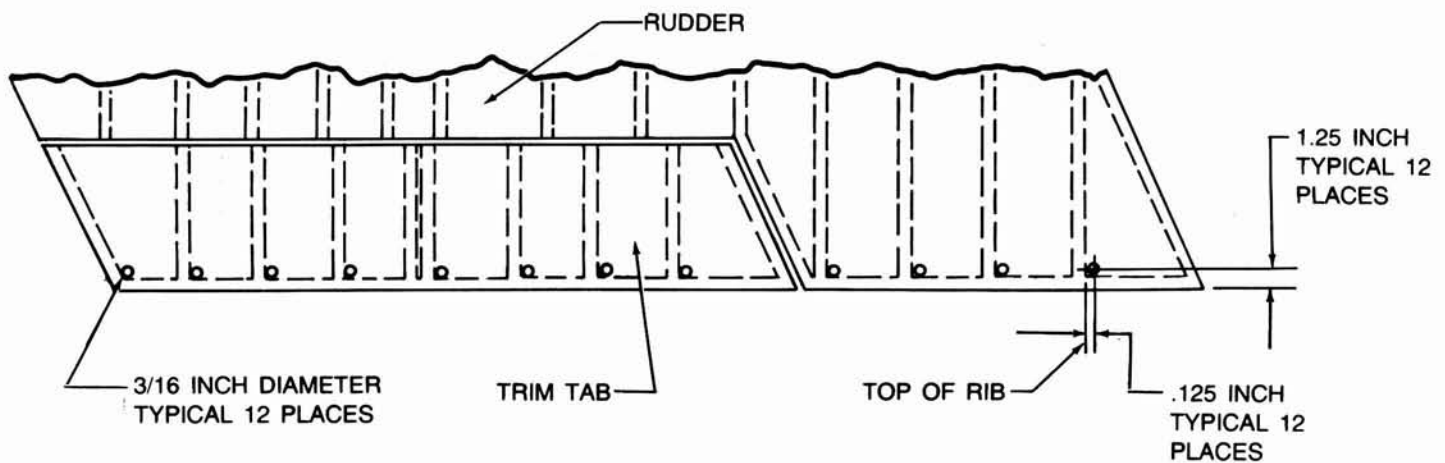
**Figure 1  
Duchess 76**

**REASON:** To reduce the possibility of water accumulating in the rudder and/or rudder trim tab by drilling additional drain holes.

5. On Duchess 76 airplanes, Drill twelve 3/16 inch diameter holes on the left side of the rudder as shown in Figure 1. The holes should be located as near to the upper surface of the ribs as possible. Do not drill into the ribs. The ribs may be located by gently squeezing the rudder and rudder trim tab with the thumb and forefinger at the trailing edge.

Use a drill stop set to a maximum depth of .100 inch (measured from the tip of the drill) when drilling all holes to prevent damage to the RH skin.

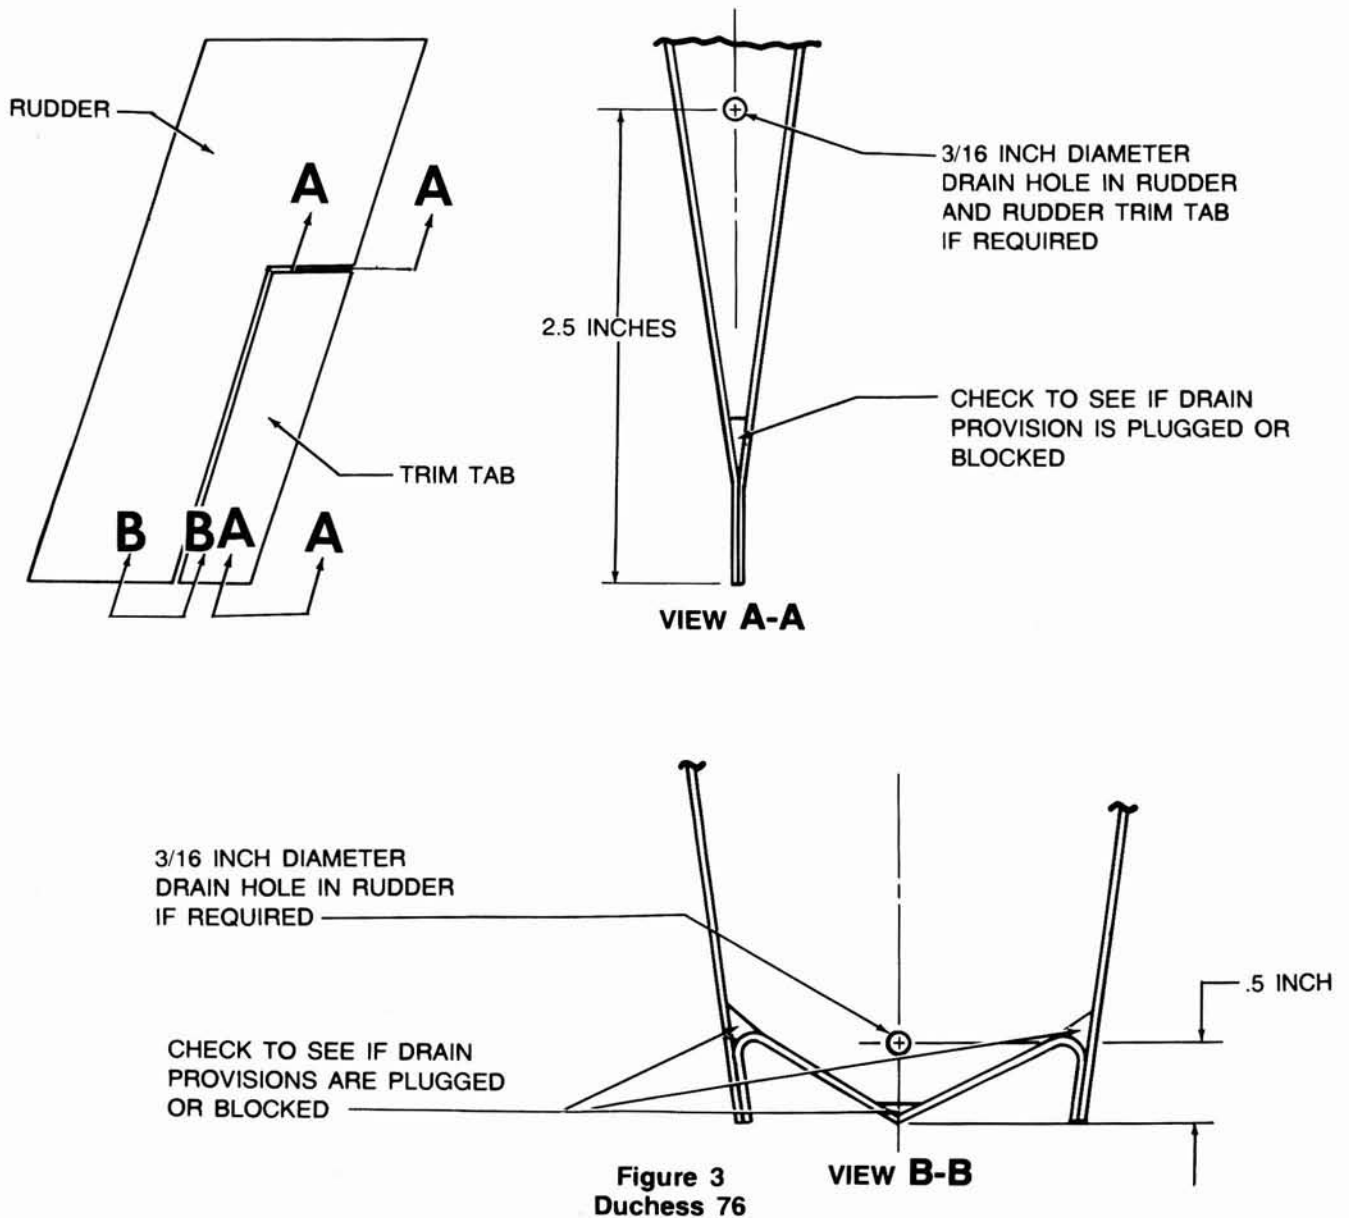
7. Inspect the bottom of the rudder and/or rudder trim tab for drain provisions between the bottom rib and skins as shown in Figure 3 (Duchess 76) or Figure 4 (Skipper 77). If drain provisions do not exist or are blocked, drill 3/16 inch diameter drain holes as shown in Figure 3 or Figure 4.
